Access Compliance Report Public Rights-of-Way (Curb Ramps)

Intersection ID: 47457 Main Street: STEELE_CREEK_RD Cross Street: WINGED_TEAL_RD Location: NE

ADA ID: 4B15B50DBBFE Ramp Type: Perp Initial Pass/Fail: Fail Overall Compliance: No Severity Score: 12.5

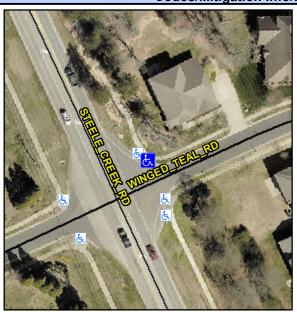
Not Found, R304.2.2

No Ramp Slope (%) N/A Ramp Length (in) 52.0 Yes Ramp XSlope (%) Yes Ramp Width (in) 48.0 N/A N/A Flare Type LT N/A Flare Type RT N/A N/A N/A Flare Slope RT (%) Flare Slope LT (%) N/A Flare Traversable LT? N/A N/A Flare Traversable RT? N/A N/A N/A DWS Provided? Landing Length (in) N/A Landing Width (in) N/A N/A **DWS Contrast?** N/A N/A N/A Landing Slope (%) DWS Length (in) N/A Landing X Slope (%) N/A N/A DWS Full Width? N/A Landing Curb? (Y/N) N/A N/A DWS Offset (in) N/A N/A Shared Landing? N/A **Gutter Ponding?** N/A N/A Gutter Slope (%) N/A Gutter Lip Ht (in) N/A N/A Gutter X Slope (%) N/A Painted X Walk1? No N/A Painted X Walk2? X Walk 1 Direction To SE X Walk 2 Direction N/A N/A X Walk 1 Width (in) X Walk 2 Width (in) X Walk 1 Slope (%) 0.2 X Walk 2 Slope (%) X Walk 1 X Slope (%) 9.6 X Walk 2 X Slope (%) N/A N/A N/A Ramp inside XWalk2? Ramp inside XWalk1? Road Slope (%) N/A N/A Clear Space? N/A Road X Slope (%) N/A Clear Space to XWalk (in) N/A N/A Any Obstructions? N/A Storm Grate/Utility Hazard? **Obstruction Type** Storm Grate/Utility Type N/A

Remove & Replace Entire Ramp.

Total Cost: \$ 1850.00
