Access Compliance Report

Public Rights-of-Way

(Curb Ramps)

Intersection ID: 31292	Main Street: DEERTON_RD	Cross Street: MUNSING_DR	Location: W
ADA ID: 4B1EE873E8D1	Ramp Type: PerpDiag	Initial Pass/Fail: Fail	Overall Compliance: No
Severity Score: 22.5			
Codes/Mitigation Info/Possible Solution		Field Measurements/Component Compliance

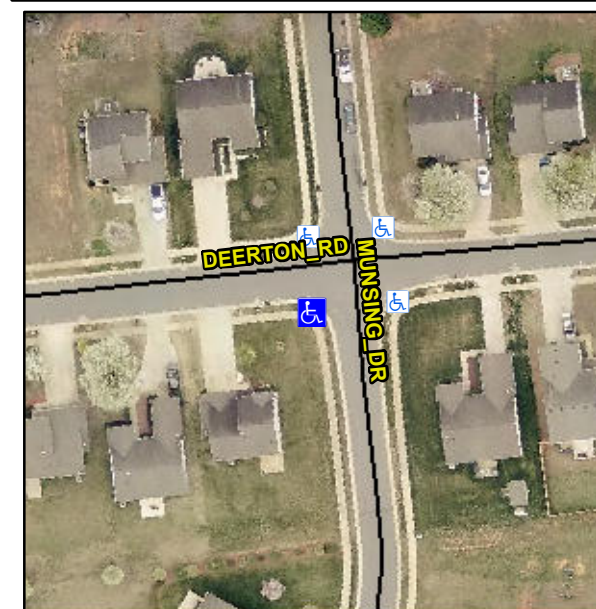
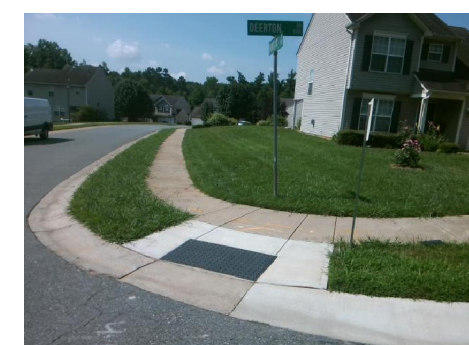
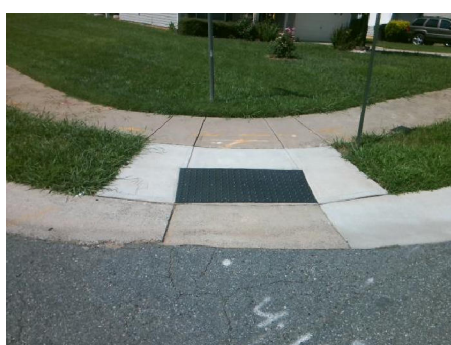
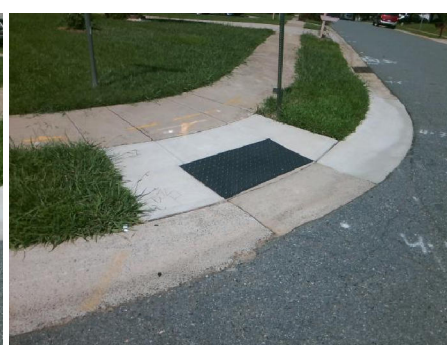
Not Found, R304.5.1, R304.2.2, R304.5.3

Compliance	Description	Data	Compliance	Description	Data
N/A	Ramp Length (in)	46.5	No	Ramp Slope (%)	8.4
No	Ramp Width (in)	40.5	No	Ramp XSlope (%)	4.8
N/A	Flare Type LT	N/A	N/A	Flare Type RT	N/A
N/A	Flare Slope LT (%)	N/A	N/A	Flare Slope RT (%)	N/A
N/A	Flare Traversable LT?	N/A	N/A	Flare Traversable RT?	N/A
N/A	Landing Length (in)	N/A	N/A	DWS Provided?	N/A
N/A	Landing Width (in)	N/A	N/A	DWS Contrast?	N/A
N/A	Landing Slope (%)	N/A	N/A	DWS Length (in)	N/A
N/A	Landing X Slope (%)	N/A	N/A	DWS Full Width?	N/A
N/A	Landing Curb? (Y/N)	N/A	N/A	DWS Offset (in)	N/A
N/A	Shared Landing?	N/A			
N/A	Gutter Ponding?	N/A	N/A	Gutter Slope (%)	N/A
N/A	Gutter Lip Ht (in)	N/A	N/A	Gutter X Slope (%)	N/A
N/A	Painted X Walk1?	No	N/A	Painted X Walk2?	No
	X Walk 1 Direction	To E		X Walk 2 Direction	To N
N/A	X Walk 1 Width (in)	N/A	N/A	X Walk 2 Width (in)	N/A
	X Walk 1 Slope (%)	1.5		X Walk 2 Slope (%)	6.4
	X Walk 1 X Slope (%)	4.4		X Walk 2 X Slope (%)	2.8

N/A	Ramp inside XWalk1?	N/A	N/A	Ramp inside XWalk2?	N/A
	Road Slope (%)	2.6	N/A	Clear Space?	N/A
	Road X Slope (%)	0.6	N/A	Clear Space to XWalk (in)	N/A
N/A	Any Obstructions?	N/A	N/A	Storm Grate/Utility Hazard?	N/A
	Obstruction Type			Storm Grate/Utility Type	
		N/A			N/A
		Yes		Surface Condition? (G/P)	Good

Remove & Replace Curb Ramp With Two New Directional Ramps or Equivalent.
