Access Compliance Report

Public Rights-of-Way

(Curb Ramps)

Intersection ID: 3559	Main Street: PERIMETER_PY	Cross Street: W_W_T_HARRIS_BV	Location: SW
ADA ID: 4B265E850994	Ramp Type: Perp	Initial Pass/Fail: Fail	Overall Compliance: No
			Severity Score: 10

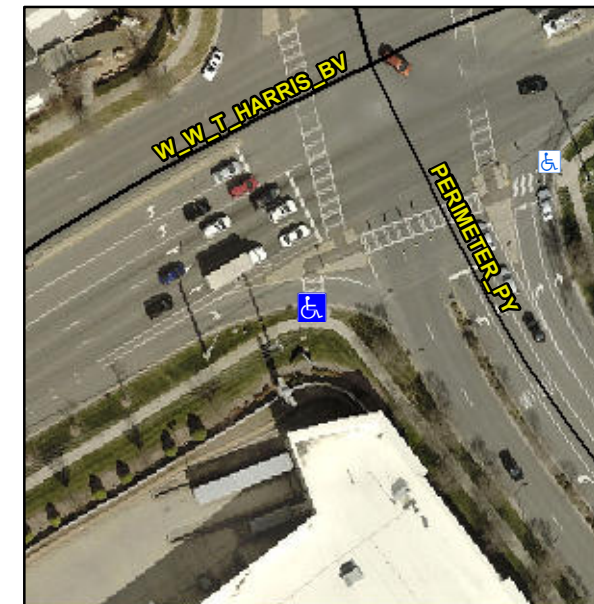
Not Found, R304.5.1, R304.5.3

Compliance	Description	Data	Compliance	Description	Data
N/A	Ramp Length (in)	60.0	Yes	Ramp Slope (%)	8.2
No	Ramp Width (in)	46.0	No	Ramp XSlope (%)	3.6
N/A	Flare Type LT	N/A	N/A	Flare Type RT	N/A
N/A	Flare Slope LT (%)	N/A	N/A	Flare Slope RT (%)	N/A
N/A	Flare Traversable LT?	N/A	N/A	Flare Traversable RT?	N/A
N/A	Landing Length (in)	N/A	N/A	DWS Provided?	N/A
N/A	Landing Width (in)	N/A	N/A	DWS Contrast?	N/A
N/A	Landing Slope (%)	N/A	N/A	DWS Length (in)	N/A
N/A	Landing X Slope (%)	N/A	N/A	DWS Full Width?	N/A
N/A	Landing Curb? (Y/N)	N/A	N/A	DWS Offset (in)	N/A
N/A	Shared Landing?	N/A			
N/A	Gutter Ponding?	N/A	N/A	Gutter Slope (%)	N/A
N/A	Gutter Lip Ht (in)	N/A	N/A	Gutter X Slope (%)	N/A
N/A	Painted X Walk1?	Yes	N/A	Painted X Walk2?	N/A
	X Walk 1 Direction	To NE		X Walk 2 Direction	N/A
N/A	X Walk 1 Width (in)	112.0	N/A	X Walk 2 Width (in)	N/A
	X Walk 1 Slope (%)	4.6		X Walk 2 Slope (%)	N/A
	X Walk 1 X Slope (%)	3.1		X Walk 2 X Slope (%)	N/A

N/A	Ramp inside XWalk1?	Yes	N/A	Ramp inside XWalk2?	N/A
	Road Slope (%)	N/A	N/A	Clear Space?	N/A
	Road X Slope (%)	N/A	N/A	Clear Space to XWalk (in)	N/A
N/A	Any Obstructions?	N/A	N/A	Storm Grate/Utility Hazard?	N/A
	Obstruction Type			Storm Grate/Utility Type	
		N/A			N/A
			Yes	Surface Condition? (G/P)	Good

Possible Solutions:

Remove & Replace Entire Ramp.
