# Access Compliance Report

## Public Rights-of-Way (Curb Ramps)

| Intersection ID: 10025569 | Main Street: E_W_T_HARRIS_BV | Cross Street: N/A | Location: SW |
| ADA ID: 4B35D7CE48B6 | Ramp Type: PerpDiag | Initial Pass/Fail: Fail | Overall Compliance: No |

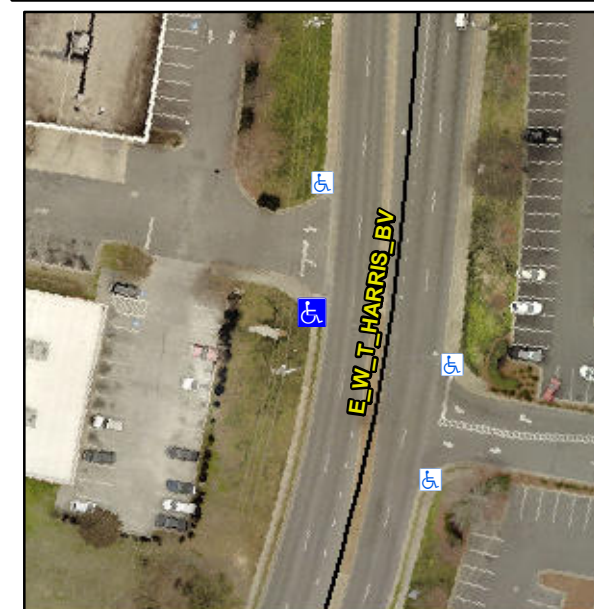
| Severity Score: 22.5 | | | |

**Not Found, R304.5.1, R304.2.2, R304.5.3**

| Compliance | Description | Data | Compliance | Description | Data |
|---|---|---|---|---|---|
| N/A | Ramp Length (in) | 70.0 | No | Ramp Slope (%) | 8.4 |
| No | Ramp Width (in) | 39.5 | No | Ramp XSlope (%) | 2.3 |

**Remove & Replace Curb Ramp With Two New Directional Ramps or Equivalent.**

Total Cost: \$ 3200.00
