Access Compliance Report

Public Rights-of-Way

(Curb Ramps)

Intersection ID: 4303	Main Street: MALLARD GROVE RD	Cross Street: W W T HARRIS BV	Location: SW
ADA ID: 4B3DA13B5859	Ramp Type: Perp	Initial Pass/Fail: Fail	Overall Compliance: No
Severity Score: 13.75			
Codes/Mitigation Info/Possible Solution		Field Measurements/Component Compliance

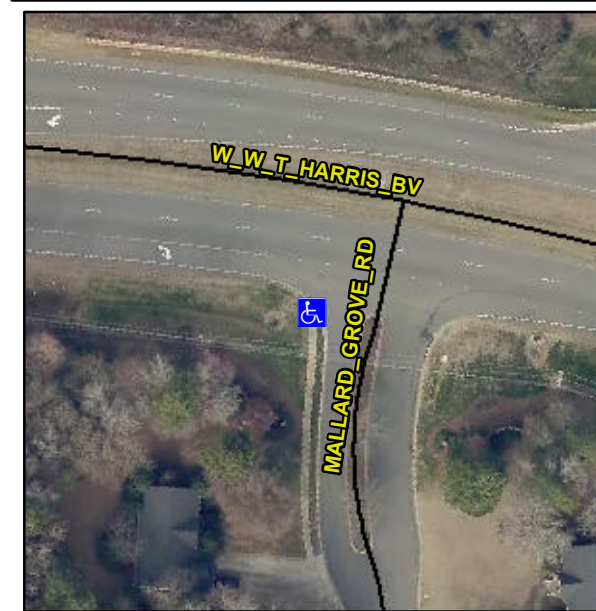
R304.2.2, R304.5.3

Compliance	Description	Data	Compliance	Description	Data
N/A	Ramp Length (in)	48.0	No	Ramp Slope (%)	9.2
Yes	Ramp Width (in)	48.0	No	Ramp XSlope (%)	3.7
N/A	Flare Type LT	N/A	N/A	Flare Type RT	N/A
N/A	Flare Slope LT (%)	N/A	N/A	Flare Slope RT (%)	N/A
N/A	Flare Traversable LT?	N/A	N/A	Flare Traversable RT?	N/A
N/A	Landing Length (in)	N/A	N/A	DWS Provided?	N/A
N/A	Landing Width (in)	N/A	N/A	DWS Contrast?	N/A
N/A	Landing Slope (%)	N/A	N/A	DWS Length (in)	N/A
N/A	Landing X Slope (%)	N/A	N/A	DWS Full Width?	N/A
N/A	Landing Curb? (Y/N)	N/A	N/A	DWS Offset (in)	N/A
N/A	Shared Landing?	N/A			
N/A	Gutter Ponding?	N/A	N/A	Gutter Slope (%)	N/A
N/A	Gutter Lip Ht (in)	N/A	N/A	Gutter X Slope (%)	N/A
N/A	Painted X Walk1?	No	N/A	Painted X Walk2?	N/A
	X Walk 1 Direction	To SE		X Walk 2 Direction	N/A
N/A	X Walk 1 Width (in)	N/A	N/A	X Walk 2 Width (in)	N/A
	X Walk 1 Slope (%)	6.8		X Walk 2 Slope (%)	N/A
	X Walk 1 X Slope (%)	7.5		X Walk 2 X Slope (%)	N/A

Possible Solutions:

Remove & Replace Entire Ramp.
