Access Compliance Report

Public Rights-of-Way

(Curb Ramps)

| Intersection ID: 23124 | Main Street: MOSS_RD | Cross Street: LAUREL_TRACE_DR | Location: S |

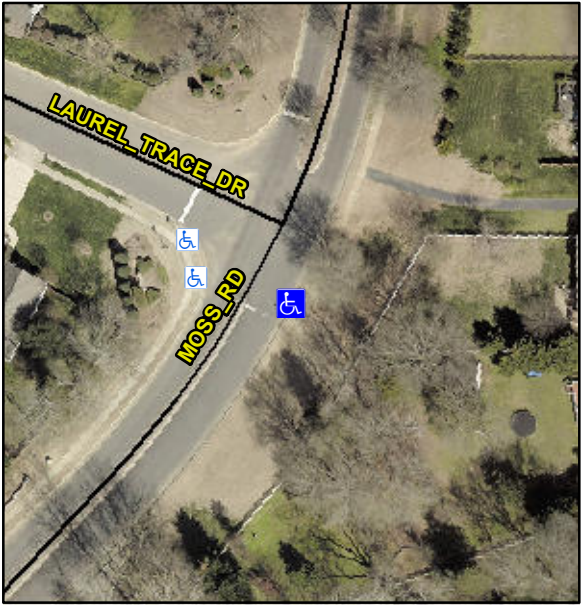
| ADA ID: 4B4175A56EA1 | Ramp Type: Perp | Initial Pass/Fail: Fail | Overall Compliance: No |
| | | Severity Score: 12.5 | |

| Codes/Mitigation Info/Possible Solution | | | Field Measurements/Component Compliance | | |
|--|---|--|---|---|---|
| <p>Surveyor Notes:</p> <p>N/A</p> <p>PROW/ADA:</p> <p>R304.2.2</p> | | | N/A | Flare Type RT | N/A |

| Codes/Mitigation Info/Possible Solution | | | Field Measurements/Component Compliance | | |
|--|---|--|---|---|---|
| | Possible Solutions: | | Compliance | Description | Data |
| | Remove & Replace Entire Ramp. | | N/A | Ramp Length (in) | 46.0 |

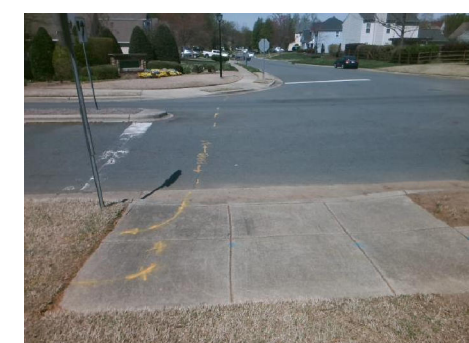
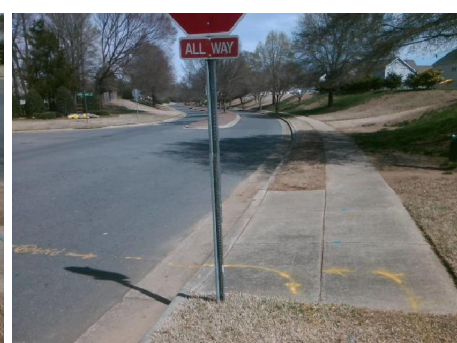
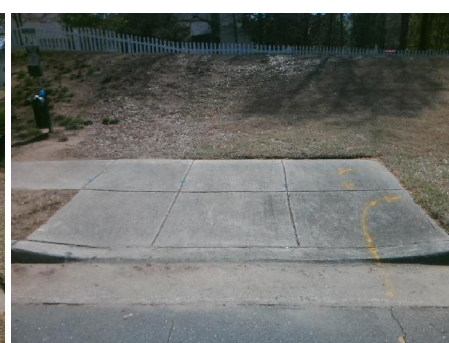
| Codes/Mitigation Info/Possible Solution | | | Field Measurements/Component Compliance | | |
|--|---|--|---|---|---|
| | | | Yes | Surface Condition? (G/P) | Good |
