# Access Compliance Report

## Public Rights-of-Way

### (Curb Ramps)

Intersection ID: 10027182	Main Street: GEMWAY_DR	Cross Street: N/A	Location: NW
ADA ID: 4B426CC4E1D7	Ramp Type: Perp	Initial Pass/Fail: Fail	Overall Compliance: No
		Severity Score: 25

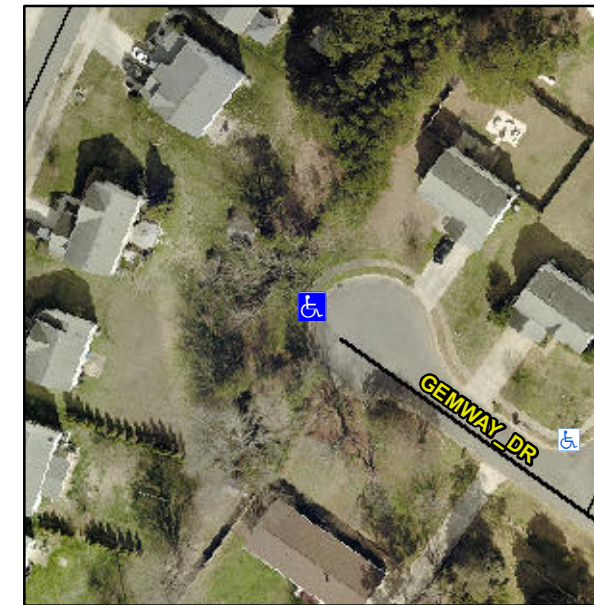
**R304.2.2**

Compliance	Description	Data	Compliance	Description	Data
N/A	Ramp Length (in)	50.0	No	Ramp Slope (%)	12.8
Yes	Ramp Width (in)	60.0	Yes	Ramp XSlope (%)	0.7
N/A	Flare Type LT	N/A	N/A	Flare Type RT	N/A
N/A	Flare Slope LT (%)	N/A	N/A	Flare Slope RT (%)	N/A
N/A	Flare Traversable LT?	N/A	N/A	Flare Traversable RT?	N/A
N/A	Landing Length (in)	N/A	N/A	DWS Provided?	N/A
N/A	Landing Width (in)	N/A	N/A	DWS Contrast?	N/A
N/A	Landing Slope (%)	N/A	N/A	DWS Length (in)	N/A
N/A	Landing X Slope (%)	N/A	N/A	DWS Full Width?	N/A
N/A	Landing Curb? (Y/N)	N/A	N/A	DWS Offset (in)	N/A
N/A	Shared Landing?	N/A			
N/A	Gutter Ponding?	N/A	N/A	Gutter Slope (%)	N/A
N/A	Gutter Lip Ht (in)	N/A	N/A	Gutter X Slope (%)	N/A
N/A	Painted X Walk1?	No	N/A	Painted X Walk2?	N/A
	X Walk 1 Direction	To SE		X Walk 2 Direction	N/A
N/A	X Walk 1 Width (in)	N/A	N/A	X Walk 2 Width (in)	N/A
	X Walk 1 Slope (%)	0.7		X Walk 2 Slope (%)	N/A
	X Walk 1 X Slope (%)	2.1		X Walk 2 X Slope (%)	N/A

**Remove & Replace Entire Ramp.**

**\$ 1850.00**
