Access Compliance Report

Public Rights-of-Way

(Curb Ramps)

Intersection ID: 13223	Main Street: BIRCHCREST_DR	Cross Street: WOODLEAF_RD	Location: SW
ADA ID: 4B488B9955C3	Ramp Type: Perp	Initial Pass/Fail: Fail	Overall Compliance: No
Severity Score: 25			
Codes/Mitigation Info/Possible Solution		Field Measurements/Component Compliance

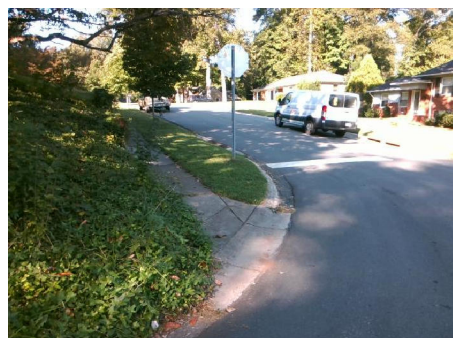
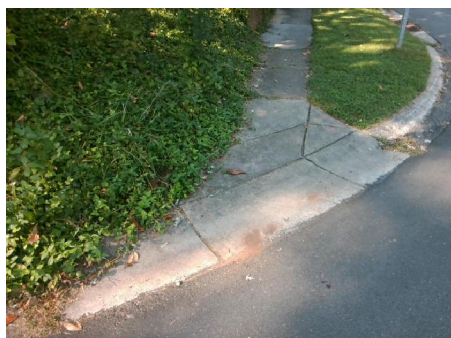
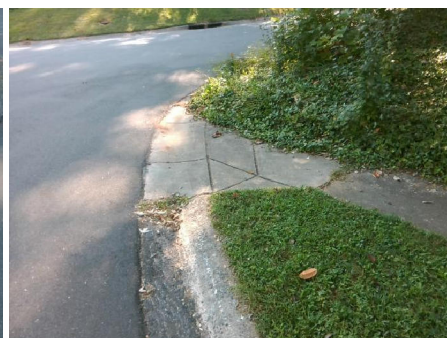
Compliance	Description	Data	Compliance	Description	Data
N/A	Ramp Length (in)	26.5	No	Ramp Slope (%)	13.1
Yes	Ramp Width (in)	48.0	Yes	Ramp XSlope (%)	1.9
N/A	Flare Type LT	N/A	N/A	Flare Type RT	N/A
N/A	Flare Slope LT (%)	N/A	N/A	Flare Slope RT (%)	N/A
N/A	Flare Traversable LT?	N/A	N/A	Flare Traversable RT?	N/A
N/A	Landing Length (in)	N/A	N/A	DWS Provided?	N/A
N/A	Landing Width (in)	N/A	N/A	DWS Contrast?	N/A
N/A	Landing Slope (%)	N/A	N/A	DWS Length (in)	N/A
N/A	Landing X Slope (%)	N/A	N/A	DWS Full Width?	N/A
N/A	Landing Curb? (Y/N)	N/A	N/A	DWS Offset (in)	N/A
N/A	Shared Landing?	N/A			
N/A	Gutter Ponding?	N/A	N/A	Gutter Slope (%)	N/A
N/A	Gutter Lip Ht (in)	N/A	N/A	Gutter X Slope (%)	N/A
N/A	Painted X Walk1?	No	N/A	Painted X Walk2?	N/A
	X Walk 1 Direction	To E		X Walk 2 Direction	N/A
N/A	X Walk 1 Width (in)	N/A	N/A	X Walk 2 Width (in)	N/A
	X Walk 1 Slope (%)	3.8		X Walk 2 Slope (%)	N/A
	X Walk 1 X Slope (%)	0.2		X Walk 2 X Slope (%)	N/A

N/A	Ramp inside XWalk1?	N/A	N/A	Ramp inside XWalk2?	N/A
	Road Slope (%)	0.2	N/A	Clear Space?	N/A
	Road X Slope (%)	3.8	N/A	Clear Space to XWalk (in)	N/A
N/A	Any Obstructions?	N/A	N/A	Storm Grate/Utility Hazard?	N/A
	Obstruction Type			Storm Grate/Utility Type	
		N/A			N/A
			Yes	Surface Condition? (G/P)	Good

Possible Solutions:

Remove & Replace Entire Ramp.

Not Found, R304.2.2
