# Access Compliance Report

## Public Rights-of-Way

### (Curb Ramps)

Intersection ID: 10037290	Main Street: SARDIS_RD_NORTH	Cross Street: N/A	Location: NW
ADA ID: 4B4B424105DC	Ramp Type: Directional1	Initial Pass/Fail: Fail	Overall Compliance: No
		Severity Score: 25

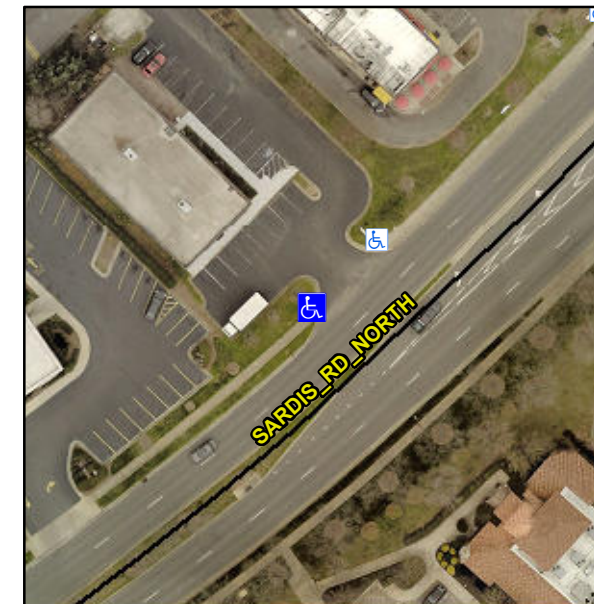
Compliance	Description	Data	Compliance	Description	Data
N/A	Ramp Length (in)	38.0	N/A	Grade Break?	N/A
Yes	Ramp Width (in)	60.0	N/A	Grade Break Slope (%)	0.0
Yes	Ramp Slope (%)	6.8	N/A	Grade Break XSlope (%)	0.0
No	Ramp XSlope (%)	9.4			
N/A	Flare Type LT	N/A	N/A	Flare Type RT	N/A
N/A	Flare Slope LT (%)	N/A	N/A	Flare Slope RT (%)	0.0
N/A	Flare Traversable LT?	N/A	N/A	Flare Traversable RT?	N/A
N/A	Landing Length (in)	0.0	N/A	DWS Provided?	N/A
N/A	Landing Width (in)	0.0	N/A	DWS Contrast?	N/A
N/A	Landing Slope (%)	0.0	N/A	DWS Length (in)	N/A
N/A	Landing X Slope (%)	0.0	N/A	DWS Full Width?	N/A
N/A	Landing Curb? (Y/N)	N/A	N/A	DWS Offset LT (in)	N/A
N/A	Shared Landing?	N/A	N/A	DWS Offset RT (in)	N/A
N/A	Gutter Ponding?	0.0	N/A	Gutter Slope (%)	N/A
N/A	Gutter Lip Ht (in)	0.0	N/A	Gutter X Slope (%)	N/A
N/A	Painted X Walk1?	No		Road Slope (%)	2.2
	X Walk 1 Direction	To NE		Road X Slope (%)	2.5
	X Walk 1 Width (in)	N/A		Clear Space?	N/A

X Walk 1 Slope (%)	2.2	N/A	Clear Space to XWalk (in)	N/A
	X Walk 1 X Slope (%)	2.5	N/A	Storm Grate/Utility Hazard?	N/A
N/A	Ramp inside XWalk1?	N/A		Storm Grate/Utility Type	
N/A	Any Obstructions?	N/A			N/A
	Obstruction Type		Yes	Surface Condition? (G/P)	Good
			N/A	Curb Slope (%)	9.8

**Remove & Replace Entire Ramp.**
