Access Compliance Report

Public Rights-of-Way

(Curb Ramps)

Intersection ID: 9982	Main Street: E_36TH_ST	Cross Street: N_DAVIDSON_ST	Location: S
ADA ID: 4B599E2DF3DA	Ramp Type: PerpDiag	Initial Pass/Fail: Fail	Overall Compliance: No
Severity Score: 12.5			
Codes/Mitigation Info/Possible Solution		Field Measurements/Component Compliance

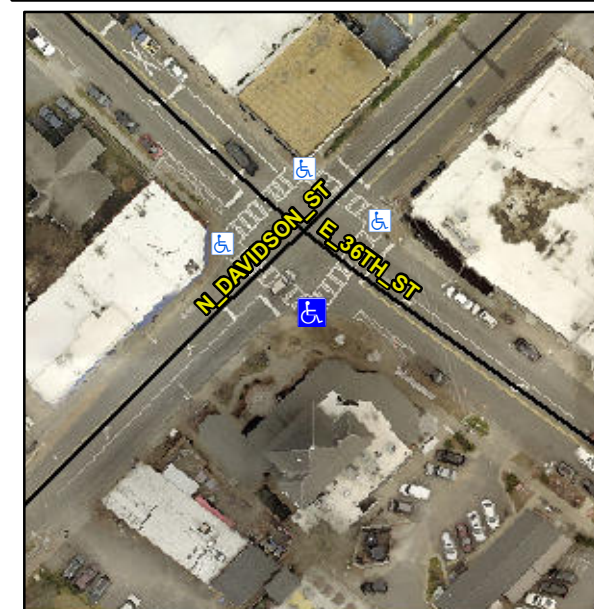
Compliance	Description	Data	Compliance	Description	Data
N/A	Ramp Length (in)	66.0	No	Ramp Slope (%)	9.3
Yes	Ramp Width (in)	48.0	Yes	Ramp XSlope (%)	0.8
N/A	Flare Type LT	N/A	N/A	Flare Type RT	N/A
N/A	Flare Slope LT (%)	N/A	N/A	Flare Slope RT (%)	N/A
N/A	Flare Traversable LT?	N/A	N/A	Flare Traversable RT?	N/A
N/A	Landing Length (in)	N/A	N/A	DWS Provided?	N/A
N/A	Landing Width (in)	N/A	N/A	DWS Contrast?	N/A
N/A	Landing Slope (%)	N/A	N/A	DWS Length (in)	N/A
N/A	Landing X Slope (%)	N/A	N/A	DWS Full Width?	N/A
N/A	Landing Curb? (Y/N)	N/A	N/A	DWS Offset (in)	N/A
N/A	Shared Landing?	N/A			
N/A	Gutter Ponding?	N/A	N/A	Gutter Slope (%)	N/A
N/A	Gutter Lip Ht (in)	1.0	N/A	Gutter X Slope (%)	N/A
N/A	Painted X Walk1?	Yes	N/A	Painted X Walk2?	Yes
	X Walk 1 Direction	To NE		X Walk 2 Direction	To NW
N/A	X Walk 1 Width (in)	110.0	N/A	X Walk 2 Width (in)	108.0
	X Walk 1 Slope (%)	4.5		X Walk 2 Slope (%)	3.2
	X Walk 1 X Slope (%)	1.4		X Walk 2 X Slope (%)	2.3

N/A	Ramp inside XWalk1?	Yes	N/A	Ramp inside XWalk2?	Yes
	Road Slope (%)	2.6	N/A	Clear Space?	N/A
	Road X Slope (%)	4.3	N/A	Clear Space to XWalk (in)	N/A
N/A	Any Obstructions?	N/A	N/A	Storm Grate/Utility Hazard?	N/A
	Obstruction Type			Storm Grate/Utility Type	
		N/A			N/A
		Yes		Surface Condition? (G/P)	Good

Possible Solutions:

Remove & Replace Curb Ramp With Two New Directional Ramps or Equivalent.

R304.2.2
