# Access Compliance Report

## Public Rights-of-Way

### (Curb Ramps)

Intersection ID: 9246	Main Street: GRIMES_ST	Cross Street: NORRIS_AV	Location:	E
ADA ID: 4B64323A0650	Ramp Type: Perp	Initial Pass/Fail: Fail	Overall Compliance: No	Severity Score: 25

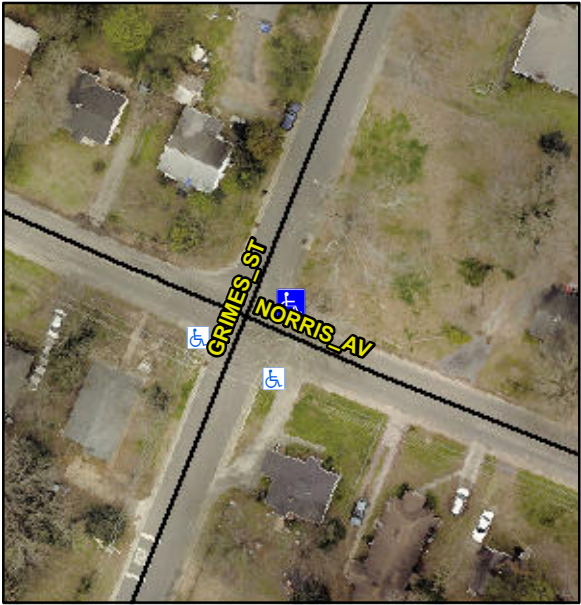
Possible Solutions:		<b>Compliance</b>	<b>Description</b>	<b>Data</b>
	<b>Remove &amp; Replace Entire Ramp.</b>		<b>No</b>	Ramp Length (in)	53.0
			<b>Yes</b>	Ramp Width (in)	90.0
			<b>N/A</b>	Flare Type LT	N/A
			<b>N/A</b>	Flare Slope LT (%)	N/A
			<b>N/A</b>	Flare Traversable LT?	N/A
			<b>N/A</b>	Landing Length (in)	N/A
			<b>N/A</b>	Landing Width (in)	N/A
			<b>N/A</b>	Landing Slope (%)	N/A
			<b>N/A</b>	Landing X Slope (%)	N/A
<p>Surveyor Notes:</p> <p><b>N/A</b></p> <p>PROW/ADA:</p> <p><b>Not Found, R304.2.2</b></p>			<b>N/A</b>	Flare Type RT	N/A
			<b>N/A</b>	Flare Slope RT (%)	N/A
			<b>N/A</b>	Flare Traversable RT?	N/A
			<b>N/A</b>	DWS Provided?	N/A
			<b>N/A</b>	DWS Contrast?	N/A
			<b>N/A</b>	DWS Length (in)	N/A
			<b>N/A</b>	DWS Full Width?	N/A
			<b>N/A</b>	DWS Offset (in)	N/A
			<b>N/A</b>	Shared Landing?	N/A
