Access Compliance Report

Public Rights-of-Way

(Curb Ramps)

Intersection ID: 50464	Main Street: LENOX_POINTE_DR	Cross Street: SANDY_PORTER_RD	Location: SW
ADA ID: 4B6D722BF88F	Ramp Type: Perp	Initial Pass/Fail: Fail	Overall Compliance: No
Severity Score: 25			
Codes/Mitigation Info/Possible Solution		Field Measurements/Component Compliance

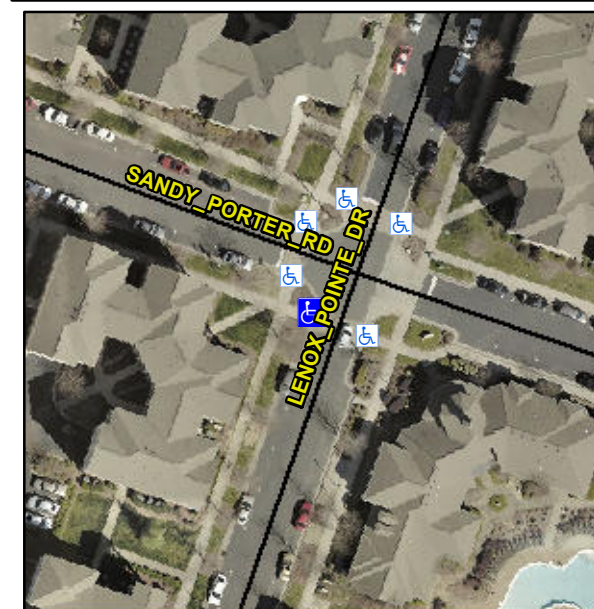
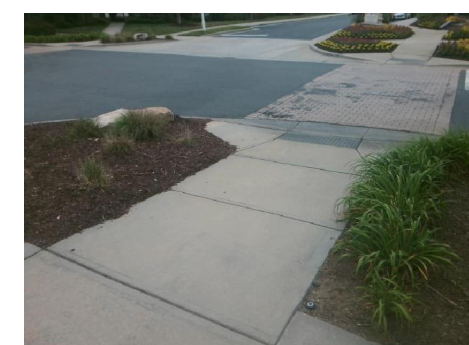
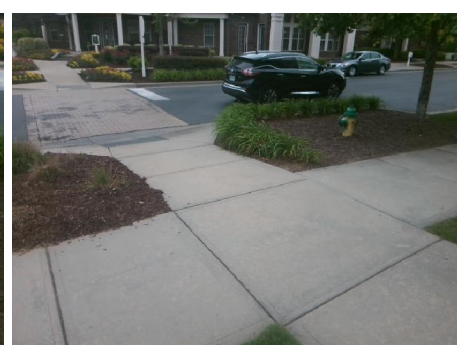
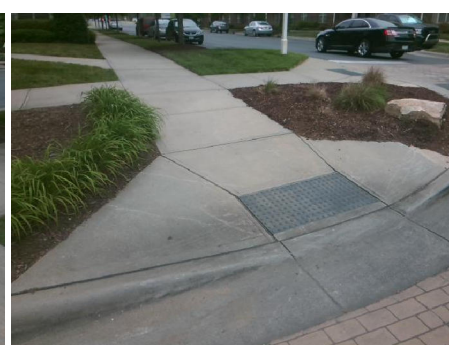
Not Found, R304.2.2

Compliance	Description	Data	Compliance	Description	Data
N/A	Ramp Length (in)	177.0	No	Ramp Slope (%)	14.9
Yes	Ramp Width (in)	48.0	Yes	Ramp XSlope (%)	0.5
N/A	Flare Type LT	N/A	N/A	Flare Type RT	N/A
N/A	Flare Slope LT (%)	N/A	N/A	Flare Slope RT (%)	N/A
N/A	Flare Traversable LT?	N/A	N/A	Flare Traversable RT?	N/A
N/A	Landing Length (in)	N/A	N/A	DWS Provided?	N/A
N/A	Landing Width (in)	N/A	N/A	DWS Contrast?	N/A
N/A	Landing Slope (%)	N/A	N/A	DWS Length (in)	N/A
N/A	Landing X Slope (%)	N/A	N/A	DWS Full Width?	N/A
N/A	Landing Curb? (Y/N)	N/A	N/A	DWS Offset (in)	N/A
N/A	Shared Landing?	N/A			
N/A	Gutter Ponding?	N/A	N/A	Gutter Slope (%)	N/A
N/A	Gutter Lip Ht (in)	N/A	N/A	Gutter X Slope (%)	N/A
N/A	Painted X Walk1?	Yes	N/A	Painted X Walk2?	N/A
	X Walk 1 Direction	To SE		X Walk 2 Direction	N/A
N/A	X Walk 1 Width (in)	144.0	N/A	X Walk 2 Width (in)	N/A
	X Walk 1 Slope (%)	1.5		X Walk 2 Slope (%)	N/A
	X Walk 1 X Slope (%)	0.9		X Walk 2 X Slope (%)	N/A

N/A	Ramp inside XWalk1?	Yes	N/A	Ramp inside XWalk2?	N/A
	Road Slope (%)	N/A	N/A	Clear Space?	N/A
	Road X Slope (%)	N/A	N/A	Clear Space to XWalk (in)	N/A
N/A	Any Obstructions?	N/A	N/A	Storm Grate/Utility Hazard?	N/A
	Obstruction Type			Storm Grate/Utility Type	
		N/A			N/A
			Yes	Surface Condition? (G/P)	Good

Possible Solutions:

Remove & Replace Entire Ramp.
