# Access Compliance Report

## Public Rights-of-Way

### (Curb Ramps)

| Intersection ID: 53897 | Main Street: ELGIN_MOOR_RD | Cross Street: DALLAS_BAY_RD | Location: NW |

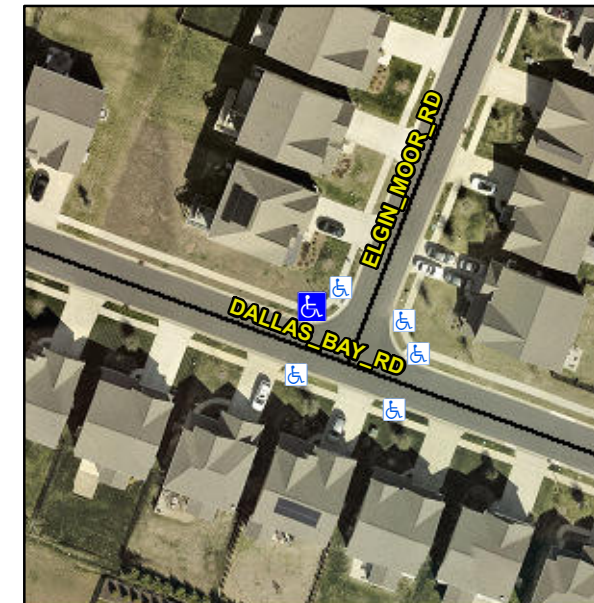
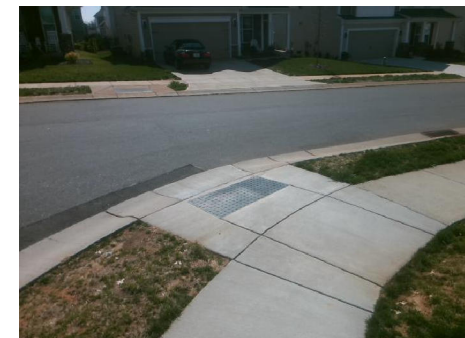
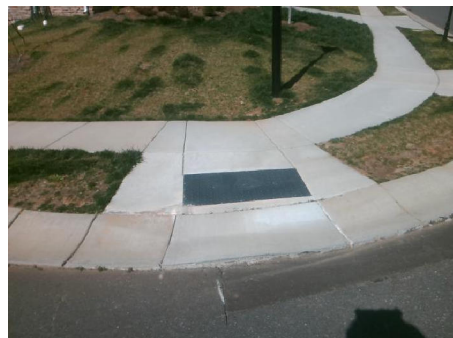
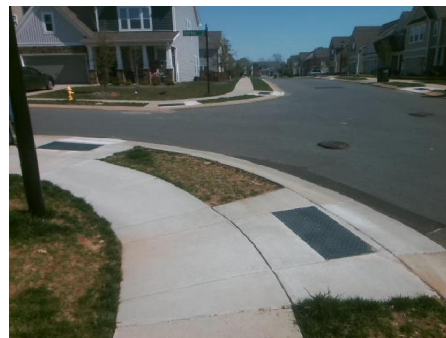
| ADA ID: 4B719F6D15D8 | Ramp Type: BlendTrans1 | Initial Pass/Fail: Fail | Overall Compliance: No |

**Not Found, R304.5.1, R304.5.3**

| Compliance | Description | Data | Compliance | Description | Data |
|---|---|---|---|---|---|
| No | Ramp Width (in) | 45.0 | No | BlendTrans XSlope (%) | 10.1 |
| | | | No | Curb Slope (%) | 15.9 |

**Remove & Replace Curb Ramp With Two New Directional Ramps or Equivalent.**
