# Access Compliance Report

## Public Rights-of-Way

### (Curb Ramps)

Intersection ID: 5227	Main Street: CAMERON_SPRING_RD	Cross Street: EVENTINE_CT	Location: SW
ADA ID: 4B74C0C07309	Ramp Type: Perp	Initial Pass/Fail: Fail	Overall Compliance: No
Codes/Mitigation Info/Possible Solution			Severity Score: 10
			Field Measurements/Component Compliance

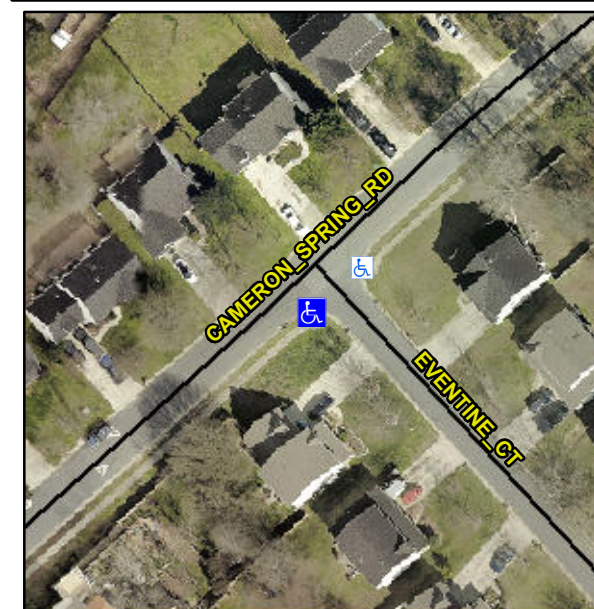
**Not Found, R304.5.1, R304.5.3**

Compliance	Description	Data	Compliance	Description	Data
N/A	Ramp Length (in)	43.0	Yes	Ramp Slope (%)	5.1
No	Ramp Width (in)	44.5	No	Ramp XSlope (%)	4.5
N/A	Flare Type LT	N/A	N/A	Flare Type RT	N/A
N/A	Flare Slope LT (%)	N/A	N/A	Flare Slope RT (%)	N/A
N/A	Flare Traversable LT?	N/A	N/A	Flare Traversable RT?	N/A
N/A	Landing Length (in)	N/A	N/A	DWS Provided?	N/A
N/A	Landing Width (in)	N/A	N/A	DWS Contrast?	N/A
N/A	Landing Slope (%)	N/A	N/A	DWS Length (in)	N/A
N/A	Landing X Slope (%)	N/A	N/A	DWS Full Width?	N/A
N/A	Landing Curb? (Y/N)	N/A	N/A	DWS Offset (in)	N/A
N/A	Shared Landing?	N/A			
N/A	Gutter Ponding?	N/A	N/A	Gutter Slope (%)	N/A
N/A	Gutter Lip Ht (in)	N/A	N/A	Gutter X Slope (%)	N/A
N/A	Painted X Walk1?	No	N/A	Painted X Walk2?	N/A
	X Walk 1 Direction	To NE		X Walk 2 Direction	N/A
N/A	X Walk 1 Width (in)	N/A	N/A	X Walk 2 Width (in)	N/A
	X Walk 1 Slope (%)	7.2		X Walk 2 Slope (%)	N/A
	X Walk 1 X Slope (%)	3.4		X Walk 2 X Slope (%)	N/A

**Remove & Replace Entire Ramp.**

Total Cost: \$ 1850.00
