# Access Compliance Report

## Public Rights-of-Way

### (Curb Ramps)

Intersection ID: 10038172	Main Street: SIR_CHARLES_PL	Cross Street: N/A	Location: SE
ADA ID: 4B7E0289481F	Ramp Type: PerpDiag	Initial Pass/Fail: Fail	Overall Compliance: No
Severity Score: 36.25			
Codes/Mitigation Info/Possible Solution		Field Measurements/Component Compliance

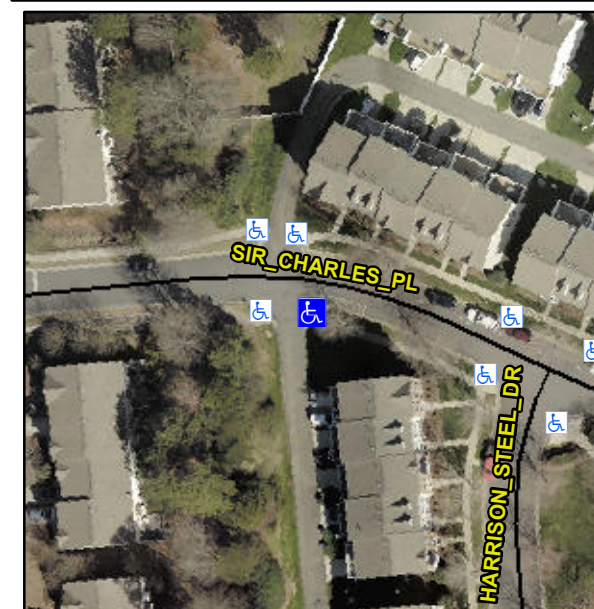
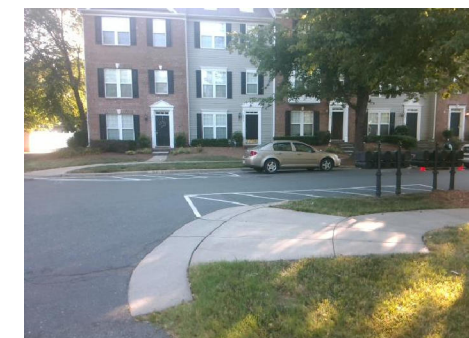
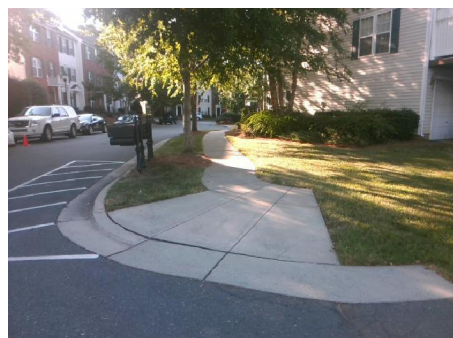
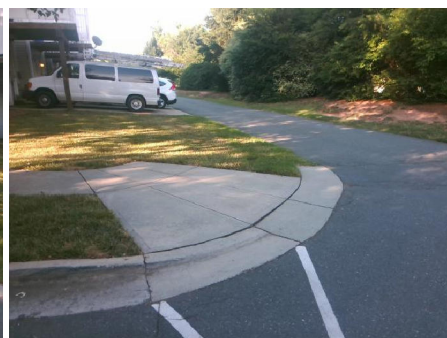
**Not Found, R304.5.1, R304.5.3**

Compliance	Description	Data	Compliance	Description	Data
N/A	Ramp Length (in)	75.0	Yes	Ramp Slope (%)	5.6
No	Ramp Width (in)	26.0	No	Ramp XSlope (%)	2.3
N/A	Flare Type LT	N/A	N/A	Flare Type RT	N/A
N/A	Flare Slope LT (%)	N/A	N/A	Flare Slope RT (%)	N/A
N/A	Flare Traversable LT?	N/A	N/A	Flare Traversable RT?	N/A
N/A	Landing Length (in)	N/A	N/A	DWS Provided?	N/A
N/A	Landing Width (in)	N/A	N/A	DWS Contrast?	N/A
N/A	Landing Slope (%)	N/A	N/A	DWS Length (in)	N/A
N/A	Landing X Slope (%)	N/A	N/A	DWS Full Width?	N/A
N/A	Landing Curb? (Y/N)	N/A	N/A	DWS Offset (in)	N/A
N/A	Shared Landing?	N/A			
N/A	Gutter Ponding?	N/A	N/A	Gutter Slope (%)	N/A
N/A	Gutter Lip Ht (in)	N/A	N/A	Gutter X Slope (%)	N/A
N/A	Painted X Walk1?	No	N/A	Painted X Walk2?	No
	X Walk 1 Direction	To N		X Walk 2 Direction	To W
N/A	X Walk 1 Width (in)	N/A	N/A	X Walk 2 Width (in)	N/A
	X Walk 1 Slope (%)	2.2		X Walk 2 Slope (%)	1.0
	X Walk 1 X Slope (%)	2.3		X Walk 2 X Slope (%)	1.1

N/A	Ramp inside XWalk1?	N/A	N/A	Ramp inside XWalk2?	N/A
	Road Slope (%)	2.2	N/A	Clear Space?	N/A
	Road X Slope (%)	1.7	N/A	Clear Space to XWalk (in)	N/A
N/A	Any Obstructions?	N/A	N/A	Storm Grate/Utility Hazard?	N/A
	Obstruction Type			Storm Grate/Utility Type	
		N/A			N/A
			Yes	Surface Condition? (G/P)	Good

**Remove & Replace Curb Ramp With Two New Directional Ramps or Equivalent.**
