Access Compliance Report Public Rights-of-Way (Curb Ramps)

Intersection ID: 18716 Main Street: COLONY RD Cross Street: RUNNYMEDE_LN Location: ADA ID: 4B7FD6F2B670 Ramp Type: PerpDiag Initial Pass/Fail: Fail **Overall Compliance: No** Severity Score: 13.75

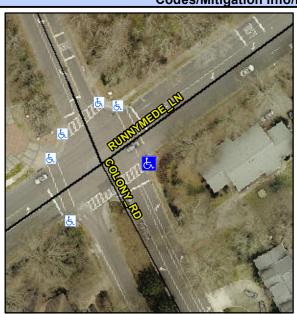
Comp	liance Description	Data		pliance Description	Data
N/A	Ramp Length (in)	79.0	No	Ramp Slope (%)	10.3
Yes	Ramp Width (in)	48.0	No	Ramp XSlope (%)	3.9
N/A	Flare Type LT	N/A	N/A	Flare Type RT	N/A
N/A	Flare Slope LT (%)	N/A	N/A	Flare Slope RT (%)	N/A
N/A	Flare Traversable LT?	N/A	N/A	Flare Traversable RT?	N/A
N/A	Landing Length (in)	N/A	N/A	DWS Provided?	N/A
N/A	Landing Width (in)	N/A	N/A	DWS Contrast?	N/A
N/A	Landing Slope (%)	N/A	N/A	DWS Length (in)	N/A
N/A	Landing X Slope (%)	N/A	N/A	DWS Full Width?	N/A
N/A	Landing Curb? (Y/N)	N/A	N/A	DWS Offset (in)	N/A
N/A	Shared Landing?	N/A			
N/A	Gutter Ponding?	N/A	N/A	Gutter Slope (%)	N/A
N/A	Gutter Lip Ht (in)	N/A	N/A	Gutter X Slope (%)	N/A
N/A	Painted X Walk1?	Yes	N/A	Painted X Walk2?	Yes
	X Walk 1 Direction	To NW		X Walk 2 Direction	To SW
N/A	X Walk 1 Width (in)	121.0	N/A	X Walk 2 Width (in)	114.0
	X Walk 1 Slope (%)	1.7		X Walk 2 Slope (%)	3.5
	X Walk 1 X Slope (%)	1.1		X Walk 2 X Slope (%)	4.0

N/A	Ramp inside XWalk1?	Yes	N/A	Ramp inside XWalk2?	Yes
	Road Slope (%)	2.7	N/A	Clear Space?	N/A
	Road X Slope (%)	4.3	N/A	Clear Space to XWalk (in)	N/A
N/A	Any Obstructions?	N/A	N/A	Storm Grate/Utility Hazard?	N/A
	Obstruction Type			Storm Grate/Utility Type	
		N/A			N/A
			Yes	Surface Condition? (G/P)	Good

Remove & Replace Curb Ramp With **Two New Directional Ramps or** Equivalent.

Surveyor Notes: N/A	
PROW/ADA: R304.2.2, R304.5.3	
Total Cost:	\$ 3200.00
