Access Compliance Report

Public Rights-of-Way

(Curb Ramps)

Intersection ID: 30157	Main Street: HARLAND_ST	Cross Street: OLD_PLANK_RD	Location: SE
ADA ID: 4B9943BCC27B	Ramp Type: Perp	Initial Pass/Fail: Pass	Overall Compliance: No
		Severity Score: 10

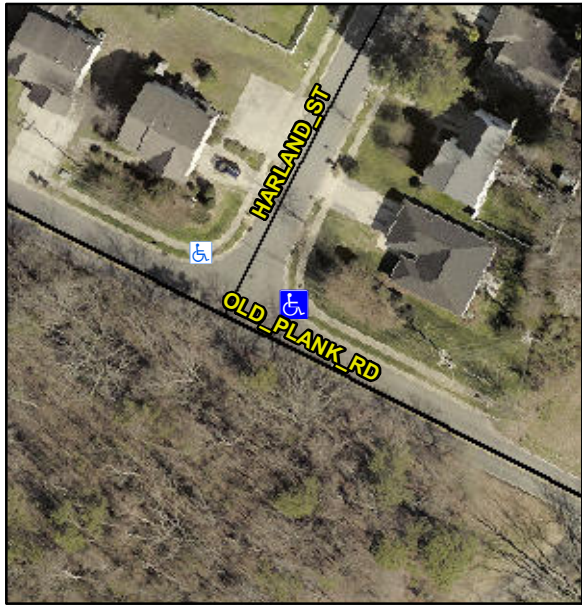
Possible Solutions:		Compliance			Description			Data	
	Remove & Replace Entire Ramp.		N/A	Ramp Length (in)	95.5	Yes	Ramp Slope (%)	7.7		
			Yes	Ramp Width (in)	97.0	Yes	Ramp XSlope (%)	0.0		
			N/A	Flare Type LT	Sloped	N/A	Flare Type RT	N/A		
			N/A	Flare Slope LT (%)	4.3	Yes	Flare Slope RT (%)	3.2		
			N/A	Flare Traversable LT?	Yes	N/A	Flare Traversable RT?	Yes		
			No	Landing Length (in)	N/A	Yes	DWS Provided?	Yes		
			No	Landing Width (in)	N/A	Yes	DWS Contrast?	Yes		
			No	Landing Slope (%)	N/A	Yes	DWS Length (in)	24.0		
			No	Landing X Slope (%)	N/A	Yes	DWS Full Width?	Yes		
Surveyor Notes:		N/A	N/A	Landing Curb? (Y/N)	No	No	DWS Offset (in)	6.0		
PROW/ADA:		R304.2.1, R304.2.2-Perp, R304.3.2-Para, R304.5.3, R305.2	N/A	Shared Landing?	No					
			Yes	Gutter Ponding?	No	Yes	Gutter Slope (%)	3.7		
			Yes	Gutter Lip Ht (in)	0.0	Yes	Gutter X Slope (%)	0.4

N/A	Painted X Walk1?	No	N/A	Painted X Walk2?	N/A		
				X Walk 1 Direction	To NW		X Walk 2 Direction	N/A		
			N/A	X Walk 1 Width (in)	N/A	N/A	X Walk 2 Width (in)	N/A		
				X Walk 1 Slope (%)	1.9		X Walk 2 Slope (%)	N/A		
				X Walk 1 X Slope (%)	0.1		X Walk 2 X Slope (%)	N/A		
			N/A	Ramp inside XWalk1?	N/A	N/A	Ramp inside XWalk2?	N/A		
				Road Slope (%)	N/A	N/A	Clear Space?	Yes		
				Road X Slope (%)	N/A	N/A	Clear Space to XWalk (in)	N/A		
			Yes	Any Obstructions?	No	Yes	Storm Grate/Utility Hazard?	No		
				Obstruction Type			Storm Grate/Utility Type			
						N/A		N/A		
						Yes	Surface Condition? (G/P)	Good		
Total Cost:		\$ 1850.00								
Street 1 Name			HARLAND ST							
Stop Condition-Street 2			StopSign							
Street 2 Name			N/A							
Stop Condition-Street 1			N/A
