Access Compliance Report

Public Rights-of-Way

(Curb Ramps)

Intersection ID: 50579	Main Street: GREAT_LAUREL_RD	Cross Street: PAPER_TREE_RD	Location: SE
ADA ID: 4BA3E29B587D	Ramp Type: Perp	Initial Pass/Fail: Fail	Overall Compliance: No
Severity Score: 8.75			
Codes/Mitigation Info/Possible Solution		Field Measurements/Component Compliance

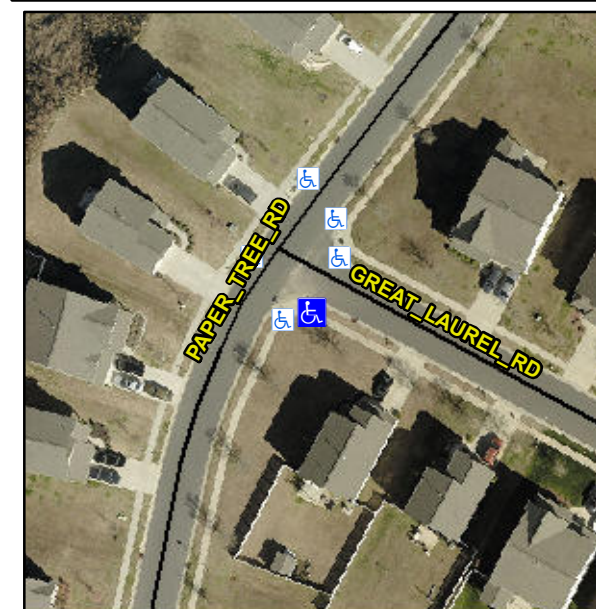
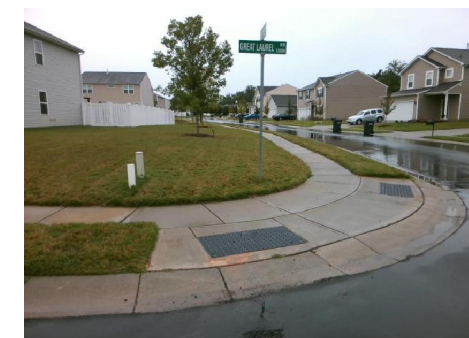
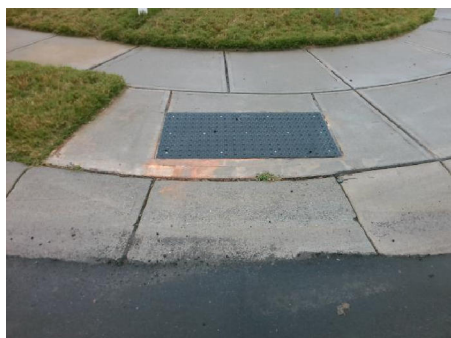
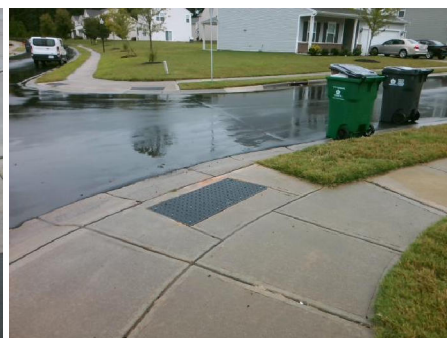
Not Found, R304.5.1

Compliance	Description	Data	Compliance	Description	Data
N/A	Ramp Length (in)	46.0	Yes	Ramp Slope (%)	7.5
No	Ramp Width (in)	47.0	Yes	Ramp XSlope (%)	1.8
N/A	Flare Type LT	N/A	N/A	Flare Type RT	N/A
N/A	Flare Slope LT (%)	N/A	N/A	Flare Slope RT (%)	N/A
N/A	Flare Traversable LT?	N/A	N/A	Flare Traversable RT?	N/A
N/A	Landing Length (in)	N/A	N/A	DWS Provided?	N/A
N/A	Landing Width (in)	N/A	N/A	DWS Contrast?	N/A
N/A	Landing Slope (%)	N/A	N/A	DWS Length (in)	N/A
N/A	Landing X Slope (%)	N/A	N/A	DWS Full Width?	N/A
N/A	Landing Curb? (Y/N)	N/A	N/A	DWS Offset (in)	N/A
N/A	Shared Landing?	N/A			
N/A	Gutter Ponding?	N/A	N/A	Gutter Slope (%)	N/A
N/A	Gutter Lip Ht (in)	N/A	N/A	Gutter X Slope (%)	N/A
N/A	Painted X Walk1?	No	N/A	Painted X Walk2?	N/A
	X Walk 1 Direction	To N		X Walk 2 Direction	N/A
N/A	X Walk 1 Width (in)	N/A	N/A	X Walk 2 Width (in)	N/A
	X Walk 1 Slope (%)	1.3		X Walk 2 Slope (%)	N/A
	X Walk 1 X Slope (%)	1.1		X Walk 2 X Slope (%)	N/A

N/A	Ramp inside XWalk1?	N/A	N/A	Ramp inside XWalk2?	N/A
	Road Slope (%)	N/A	N/A	Clear Space?	N/A
	Road X Slope (%)	N/A	N/A	Clear Space to XWalk (in)	N/A
N/A	Any Obstructions?	N/A	N/A	Storm Grate/Utility Hazard?	N/A
	Obstruction Type			Storm Grate/Utility Type	
		N/A			N/A
		Yes		Surface Condition? (G/P)	Good

Possible Solutions:

Remove & Replace Entire Ramp.
