Access Compliance Report Public Rights-of-Way (Curb Ramps)

Intersection ID: 10036975 Main Street: S_TRYON_ST Cross Street: N/A Location: N

ADA ID: 4BA5DDEAFF96 Ramp Type: Perp Initial Pass/Fail: Fail Overall Compliance: No Severity Score: 25

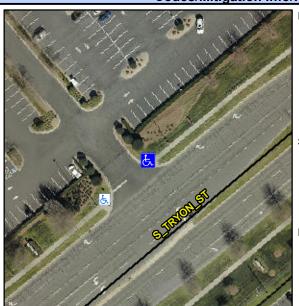
Comp	oliance Description	Data	Comp	liance	Description	Data
N/A	Ramp Length (in)	95.0	Yes	Ramp	Slope (%)	5.1
Yes	Ramp Width (in)	48.0	No	Ramp	XSlope (%)	7.2
N/A	Flare Type LT	N/A	N/A	Flare 1	Type RT	N/A
N/A	Flare Slope LT (%)	N/A	N/A	Flare S	Slope RT (%)	N/A
N/A	Flare Traversable LT?	N/A	N/A	Flare 1	raversable RT?	N/A
N/A	Landing Length (in)	N/A	N/A	DWS F	Provided?	N/A
N/A	Landing Width (in)	N/A	N/A	DWS (Contrast?	N/A
N/A	Landing Slope (%)	N/A	N/A	DWS L	_ength (in)	N/A
N/A	Landing X Slope (%)	N/A	N/A	DWS F	Full Width?	N/A
N/A	Landing Curb? (Y/N)	N/A	N/A	DWS (Offset (in)	N/A
N/A	Shared Landing?	N/A				
N/A	Gutter Ponding?	N/A	N/A	Gutter	Slope (%)	N/A
N/A	Gutter Lip Ht (in)	N/A	N/A	Gutter	X Slope (%)	N/A
N/A	Painted X Walk1?	No	N/A	Painte	d X Walk2?	N/A
	X Walk 1 Direction	To SW		X Wall	c 2 Direction	N/A
N/A	X Walk 1 Width (in)	N/A	N/A	X Wall	c 2 Width (in)	N/A
	X Walk 1 Slope (%)	3.0		X Wall	(2 Slope (%)	N/A

X Walk 1 X Slope (%)	10.3		X Wall	(2 X Slope (%)	N/A
N/A	Ramp inside XWalk1?	N/A	N/A	Ramp	inside XWalk2?	N/A
	Road Slope (%)	N/A	N/A	Clear	Space?	N/A
	Road X Slope (%)	N/A	N/A	Clear	Space to XWalk (in)	N/A
N/A	Any Obstructions?	N/A	N/A	Storm	Grate/Utility Hazard?	N/A
	Obstruction Type			Storm	Grate/Utility Type	
		N/A				N/A
			Yes	Surfac	e Condition? (G/P)	Good

Possible Solutions:
Remove & Replace Entire Ramp.

PROW/ADA:
R304.5.3
