# Access Compliance Report

## Public Rights-of-Way

### (Curb Ramps)

| Intersection ID: 53972 | Main Street: SHOPTON_RD_WEST | Cross Street: CADEN_RD | Location: SE |

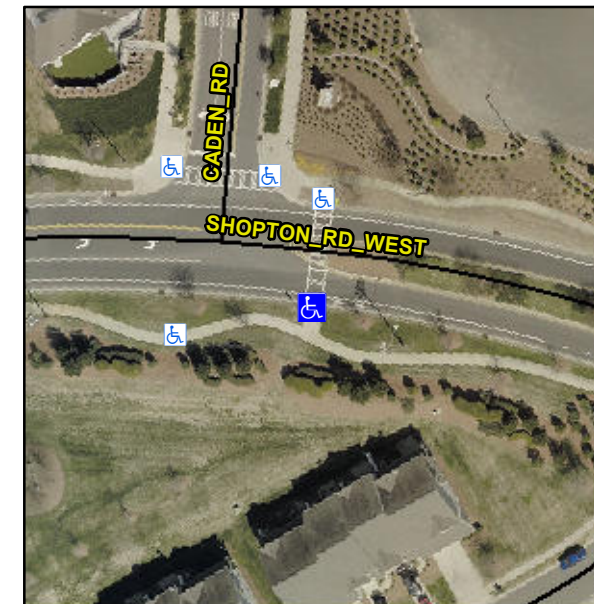
| ADA ID: 4BA6ACC05028 | Ramp Type: Perp | Initial Pass/Fail: Pass | Overall Compliance: No |

| Compliance | Description | Data | Compliance | Description | Data |
|---|---|---|---|---|---|
| No | Landing Slope (%) | 2.4 | Yes | DWS Length (in) | 24.0 |

**Remove & Replace Landing.**

Total Cost: \$ 500.00
