Access Compliance Report

Public Rights-of-Way

(Curb Ramps)

Intersection ID: 29793	Main Street: BRISTLE_TOE_LN	Cross Street: DESTIN_LN	Location: NW
ADA ID: 4BAA20A5C3A3	Ramp Type: PerpDiag	Initial Pass/Fail: Fail	Overall Compliance: No
Severity Score: 12.5			
Codes/Mitigation Info/Possible Solution		Field Measurements/Component Compliance

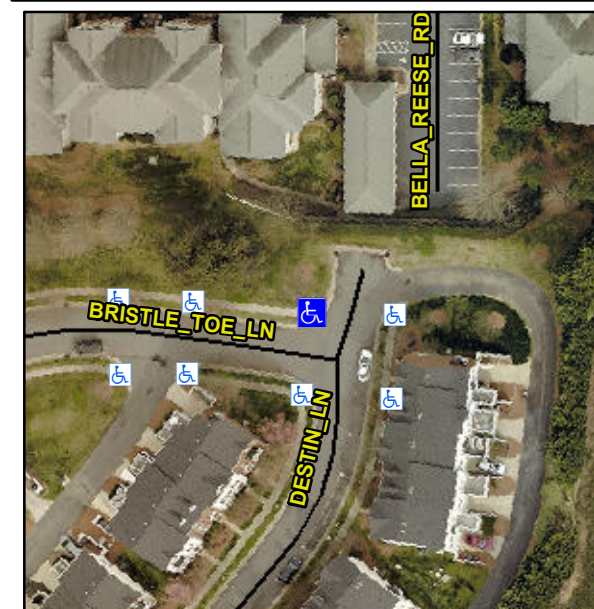
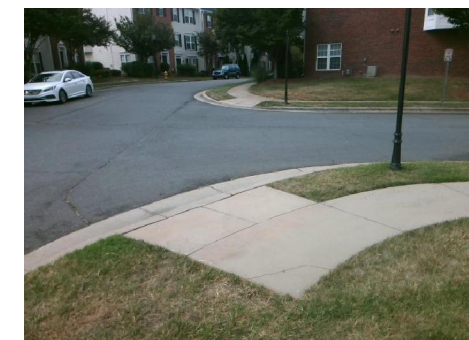
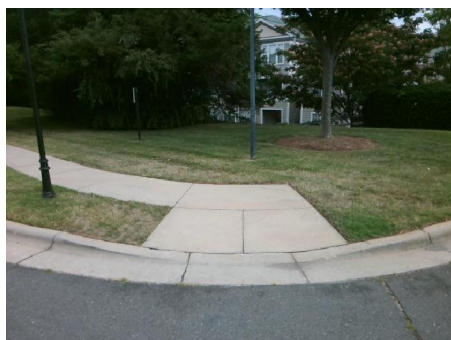
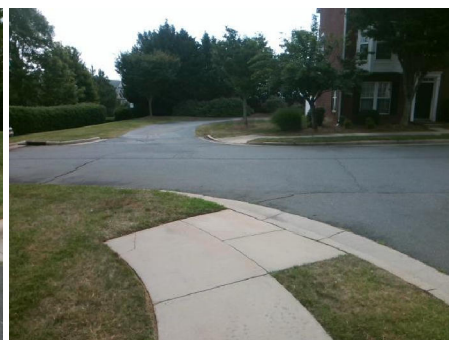
Compliance	Description	Data	Compliance	Description	Data
N/A	Ramp Length (in)	45.0	No	Ramp Slope (%)	8.9
Yes	Ramp Width (in)	48.0	Yes	Ramp XSlope (%)	0.3
N/A	Flare Type LT	N/A	N/A	Flare Type RT	N/A
N/A	Flare Slope LT (%)	N/A	N/A	Flare Slope RT (%)	N/A
N/A	Flare Traversable LT?	N/A	N/A	Flare Traversable RT?	N/A
N/A	Landing Length (in)	N/A	N/A	DWS Provided?	N/A
N/A	Landing Width (in)	N/A	N/A	DWS Contrast?	N/A
N/A	Landing Slope (%)	N/A	N/A	DWS Length (in)	N/A
N/A	Landing X Slope (%)	N/A	N/A	DWS Full Width?	N/A
N/A	Landing Curb? (Y/N)	N/A	N/A	DWS Offset (in)	N/A
N/A	Shared Landing?	N/A			
N/A	Gutter Ponding?	N/A	N/A	Gutter Slope (%)	N/A
N/A	Gutter Lip Ht (in)	N/A	N/A	Gutter X Slope (%)	N/A
N/A	Painted X Walk1?	No	N/A	Painted X Walk2?	No
	X Walk 1 Direction	To SW		X Walk 2 Direction	To SE
N/A	X Walk 1 Width (in)	N/A	N/A	X Walk 2 Width (in)	N/A
	X Walk 1 Slope (%)	2.7		X Walk 2 Slope (%)	2.0
	X Walk 1 X Slope (%)	0.2		X Walk 2 X Slope (%)	3.4

N/A	Ramp inside XWalk1?	N/A	N/A	Ramp inside XWalk2?	N/A
	Road Slope (%)	1.7	N/A	Clear Space?	N/A
	Road X Slope (%)	2.9	N/A	Clear Space to XWalk (in)	N/A
N/A	Any Obstructions?	N/A	N/A	Storm Grate/Utility Hazard?	N/A
	Obstruction Type			Storm Grate/Utility Type	
		N/A			N/A
			Yes	Surface Condition? (G/P)	Good

Possible Solutions:

Remove & Replace Curb Ramp With Two New Directional Ramps or Equivalent.

R304.2.2
