Access Compliance Report

Public Rights-of-Way

(Curb Ramps)

Intersection ID: 27731	Main Street: BALCH_MANOR_CT	Cross Street: BREM_LN	Location:	N
ADA ID: 4BB4D7B7A68E	Ramp Type: Perp	Initial Pass/Fail: Fail	Overall Compliance: No	Severity Score: 26.25
Codes/Mitigation Info/Possible Solution		Field Measurements/Component Compliance

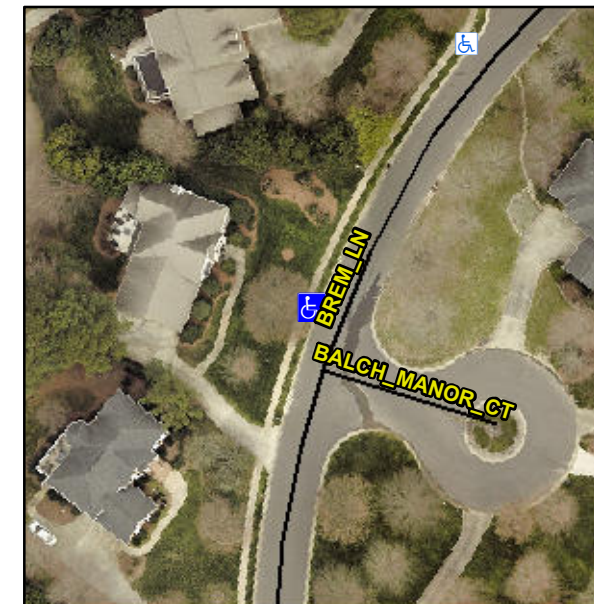
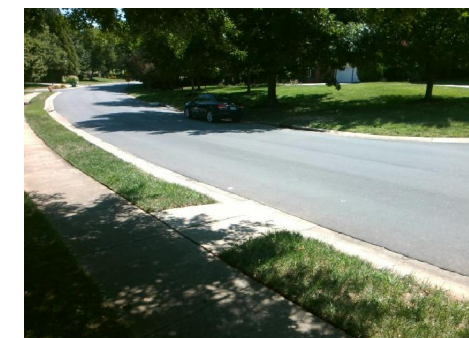
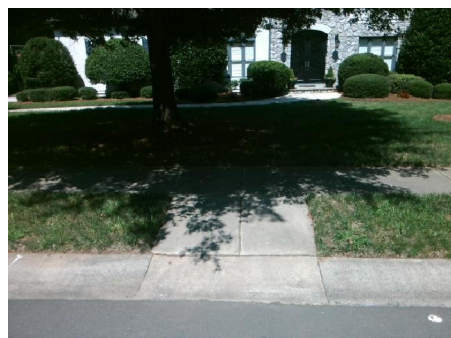
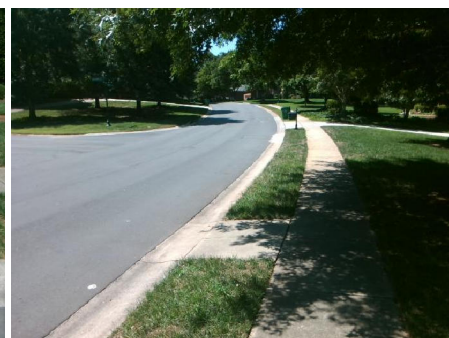
Compliance	Description	Data	Compliance	Description	Data
N/A	Ramp Length (in)	48.0	No	Ramp Slope (%)	17.3
Yes	Ramp Width (in)	60.0	Yes	Ramp XSlope (%)	3.2
N/A	Flare Type LT	N/A	N/A	Flare Type RT	N/A
N/A	Flare Slope LT (%)	N/A	N/A	Flare Slope RT (%)	N/A
N/A	Flare Traversable LT?	N/A	N/A	Flare Traversable RT?	N/A
N/A	Landing Length (in)	N/A	N/A	DWS Provided?	N/A
N/A	Landing Width (in)	N/A	N/A	DWS Contrast?	N/A
N/A	Landing Slope (%)	N/A	N/A	DWS Length (in)	N/A
N/A	Landing X Slope (%)	N/A	N/A	DWS Full Width?	N/A
N/A	Landing Curb? (Y/N)	N/A	N/A	DWS Offset (in)	N/A
N/A	Shared Landing?	N/A			
N/A	Gutter Ponding?	N/A	N/A	Gutter Slope (%)	N/A
N/A	Gutter Lip Ht (in)	N/A	N/A	Gutter X Slope (%)	N/A
N/A	Painted X Walk1?	No	N/A	Painted X Walk2?	N/A
	X Walk 1 Direction	To SE		X Walk 2 Direction	N/A
N/A	X Walk 1 Width (in)	N/A	N/A	X Walk 2 Width (in)	N/A
	X Walk 1 Slope (%)	5.3		X Walk 2 Slope (%)	N/A
	X Walk 1 X Slope (%)	3.4		X Walk 2 X Slope (%)	N/A

N/A	Ramp inside XWalk1?	N/A	N/A	Ramp inside XWalk2?	N/A
	Road Slope (%)	N/A	N/A	Clear Space?	N/A
	Road X Slope (%)	N/A	N/A	Clear Space to XWalk (in)	N/A
N/A	Any Obstructions?	N/A	N/A	Storm Grate/Utility Hazard?	N/A
	Obstruction Type			Storm Grate/Utility Type	
		N/A			N/A
			Yes	Surface Condition? (G/P)	Good

Possible Solutions:

Remove & Replace Entire Ramp.

Not Found, R304.2.2

\$ 1850.00
