Access Compliance Report

Public Rights-of-Way (Curb Ramps)

Intersection ID: 52443	Main Street: WILLOW_GREEN_PL	Cross Street: BENDING_BIRCH_PL	Location: SW
ADA ID: 4BC269D400F3	Ramp Type: Directional1	Initial Pass/Fail: Fail	Overall Compliance: No
			Severity Score: 13.75

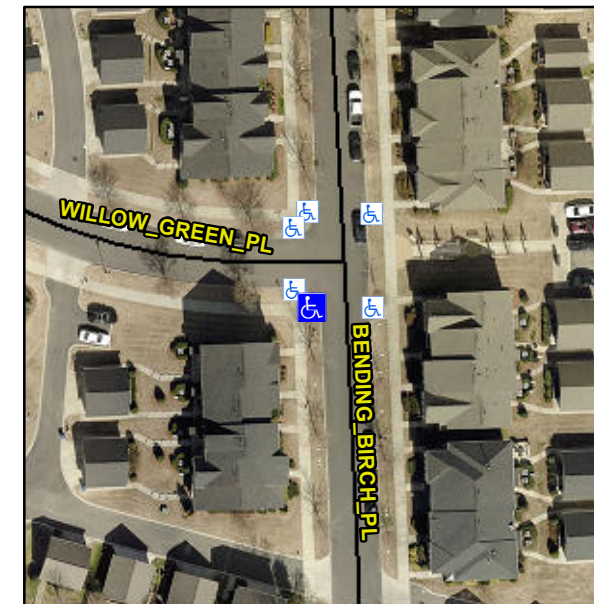
Compliance	Description	Data	Compliance	Description	Data
N/A	Ramp Length (in)	79.0	N/A	Grade Break?	N/A
Yes	Ramp Width (in)	68.0	N/A	Grade Break Slope (%)	0.0
No	Ramp Slope (%)	10.1	N/A	Grade Break XSlope (%)	0.0
No	Ramp XSlope (%)	4.2			
N/A	Flare Type LT	N/A	N/A	Flare Type RT	N/A
N/A	Flare Slope LT (%)	N/A	N/A	Flare Slope RT (%)	0.0
N/A	Flare Traversable LT?	N/A	N/A	Flare Traversable RT?	N/A
N/A	Landing Length (in)	0.0	N/A	DWS Provided?	N/A
N/A	Landing Width (in)	0.0	N/A	DWS Contrast?	N/A
N/A	Landing Slope (%)	0.0	N/A	DWS Length (in)	N/A
N/A	Landing X Slope (%)	0.0	N/A	DWS Full Width?	N/A
N/A	Landing Curb? (Y/N)	N/A	N/A	DWS Offset LT (in)	N/A
N/A	Shared Landing?	N/A	N/A	DWS Offset RT (in)	N/A
N/A	Gutter Ponding?	0.0	N/A	Gutter Slope (%)	N/A
N/A	Gutter Lip Ht (in)	0.0	N/A	Gutter X Slope (%)	N/A
N/A	Painted X Walk1?	No		Road Slope (%)	6.8
	X Walk 1 Direction	To E		Road X Slope (%)	0.9
	X Walk 1 Width (in)	N/A		Clear Space?	N/A

X Walk 1 Slope (%)	6.8	N/A	Clear Space to XWalk (in)	N/A
	X Walk 1 X Slope (%)	0.9	N/A	Storm Grate/Utility Hazard?	N/A
N/A	Ramp inside XWalk1?	N/A		Storm Grate/Utility Type	
N/A	Any Obstructions?	N/A			N/A
	Obstruction Type		Yes	Surface Condition? (G/P)	Good
			N/A	Curb Slope (%)	2.1

Possible Solutions:

Remove & Replace Entire Ramp.

R304.2.2, R304.5.3
