Access Compliance Report

Public Rights-of-Way

(Curb Ramps)

Intersection ID: 11446	Main Street: GRACE_ST	Cross Street: PEGRAM_ST	Location: NW
ADA ID: 4BC53C9462CA	Ramp Type: PerpDiag	Initial Pass/Fail: Pass	Overall Compliance: No
		Severity Score: 17.5

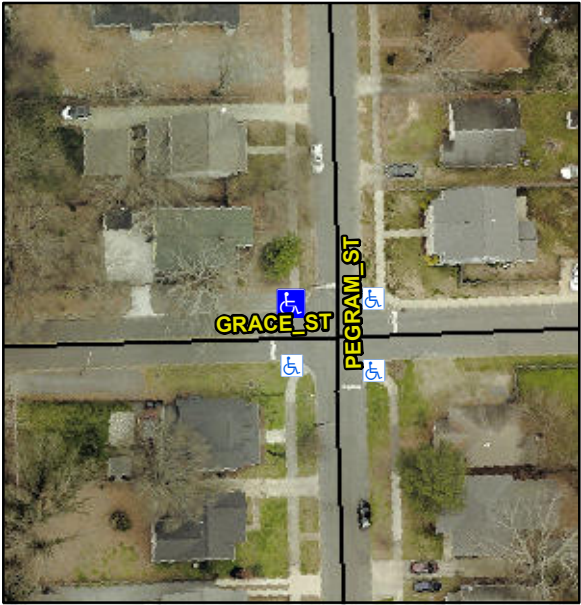
Possible Solutions:		Compliance	Description	Data
	Remove & Replace Curb Ramp With Two New Directional Ramps or Equivalent.		Yes	Ramp Length (in)	90.0
			Yes	Ramp Width (in)	54.0
			N/A	Flare Type LT	Sloped
			N/A	Flare Slope LT (%)	0.4
			N/A	Flare Traversable LT?	No
			Yes	Landing Length (in)	60.0
			Yes	Landing Width (in)	58.0
			Yes	Landing Slope (%)	1.3
			No	Landing X Slope (%)	3.4
			N/A	Landing Curb? (Y/N)	No
			N/A	Shared Landing?	No
			No	Gutter Ponding?	Yes
			No	Gutter Lip Ht (in)	2.0
			N/A	Painted X Walk1?	No
				X Walk 1 Direction	To S
			N/A	X Walk 1 Width (in)	N/A
				X Walk 1 Slope (%)	4.1
				X Walk 1 X Slope (%)	2.4
			N/A	Ramp inside XWalk1?	N/A
<p>Surveyor Notes:</p> <p>N/A</p> <p>PROW/ADA:</p> <p>Not Found, R304.5.3, R305.1.4, R305.2, R302.7, R302.7.2</p>			N/A	Flare Type RT	N/A
			N/A	Flare Slope RT (%)	2.3

N/A	Flare Traversable RT?	No
			Yes	DWS Provided?	Yes
			Yes	DWS Contrast?	Yes
			Yes	DWS Length (in)	24.0
			No	DWS Full Width?	No
			No	DWS Offset (in)	5.5
			Yes	Gutter Slope (%)	1.5
			Yes	Gutter X Slope (%)	0.1
			N/A	Painted X Walk2?	No
				X Walk 2 Direction	To E
			N/A	X Walk 2 Width (in)	N/A
				X Walk 2 Slope (%)	2.8
				X Walk 2 X Slope (%)	1.9
			N/A	Ramp inside XWalk2?	N/A
			N/A	Clear Space?	Yes
			N/A	Clear Space to XWalk (in)	N/A
			Yes	Storm Grate/Utility Hazard?	No
				Storm Grate/Utility Type	
<p>Total Cost:</p> <p>\$ 3200.00</p>			N/A		N/A
			Yes	Surface Condition? (G/P)	Good
