# Access Compliance Report

## Public Rights-of-Way

### (Curb Ramps)

Intersection ID: 18436	Main Street: E_INDEPENDENCE_BV	Cross Street: SHARON_FOREST_DR	Location: SW
ADA ID: 4BD1BFCDD2FE	Ramp Type: PerpDiag	Initial Pass/Fail: Fail	Overall Compliance: No
		Severity Score: 35

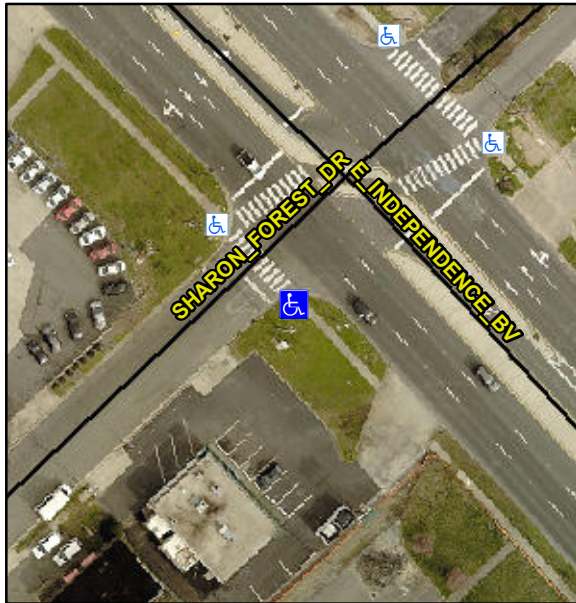
#### Field Measurements/Component Compliance

**Not Found, R304.5.1**

Compliance	Description	Data	Compliance	Description	Data
N/A	Ramp Length (in)	122.0	Yes	Ramp Slope (%)	7.9
No	Ramp Width (in)	29.0	Yes	Ramp XSlope (%)	0.6
N/A	Flare Type LT	N/A	N/A	Flare Type RT	N/A
N/A	Flare Slope LT (%)	N/A	N/A	Flare Slope RT (%)	N/A
N/A	Flare Traversable LT?	N/A	N/A	Flare Traversable RT?	N/A
N/A	Landing Length (in)	N/A	N/A	DWS Provided?	N/A
N/A	Landing Width (in)	N/A	N/A	DWS Contrast?	N/A
N/A	Landing Slope (%)	N/A	N/A	DWS Length (in)	N/A
N/A	Landing X Slope (%)	N/A	N/A	DWS Full Width?	N/A
N/A	Landing Curb? (Y/N)	N/A	N/A	DWS Offset (in)	N/A
N/A	Shared Landing?	N/A			
N/A	Gutter Ponding?	N/A	N/A	Gutter Slope (%)	N/A
N/A	Gutter Lip Ht (in)	N/A	N/A	Gutter X Slope (%)	N/A
N/A	Painted X Walk1?	No	N/A	Painted X Walk2?	Yes
	X Walk 1 Direction	To NE		X Walk 2 Direction	To NW
N/A	X Walk 1 Width (in)	N/A	N/A	X Walk 2 Width (in)	116.0
	X Walk 1 Slope (%)	2.5		X Walk 2 Slope (%)	3.3
	X Walk 1 X Slope (%)	1.8		X Walk 2 X Slope (%)	2.1

N/A	Ramp inside XWalk1?	N/A	N/A	Ramp inside XWalk2?	Yes
	Road Slope (%)	0.3	N/A	Clear Space?	N/A
	Road X Slope (%)	2.6	N/A	Clear Space to XWalk (in)	N/A
N/A	Any Obstructions?	N/A	N/A	Storm Grate/Utility Hazard?	N/A
	Obstruction Type			Storm Grate/Utility Type	
		N/A			N/A
			Yes	Surface Condition? (G/P)	Good

**Remove & Replace Curb Ramp With Two New Directional Ramps or Equivalent.**
