# Access Compliance Report

## Public Rights-of-Way

### (Curb Ramps)

| Intersection ID: 45689 | Main Street: ALOYSIA_LN | Cross Street: CANIPE_FARM_CT | Location: NE |

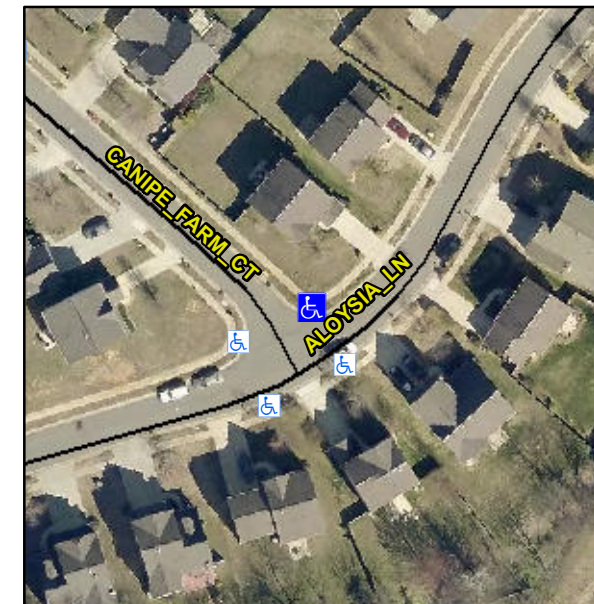
| ADA ID: 4BDDE230526C | Ramp Type: PerpDiag | Initial Pass/Fail: Fail | Overall Compliance: No |
| | | Severity Score: 10 | |

**Not Found, R304.5.1, R304.5.3**

| Compliance | Description | Data | Compliance | Description | Data |
|---|---|---|---|---|---|
| N/A | Ramp Length (in) | 47.5 | Yes | Ramp Slope (%) | 5.9 |
| No | Ramp Width (in) | 39.0 | No | Ramp XSlope (%) | 2.8 |

**Remove & Replace Curb Ramp With Two New Directional Ramps or Equivalent.**

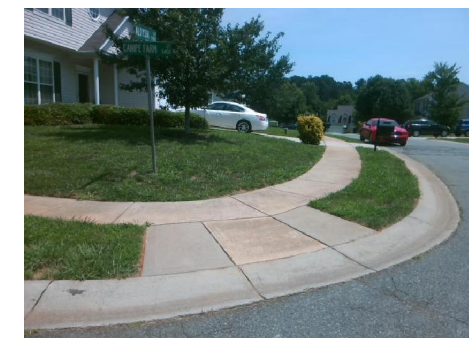
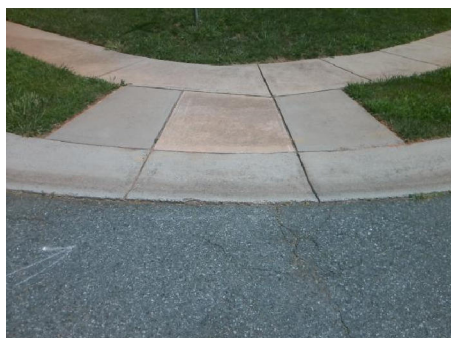
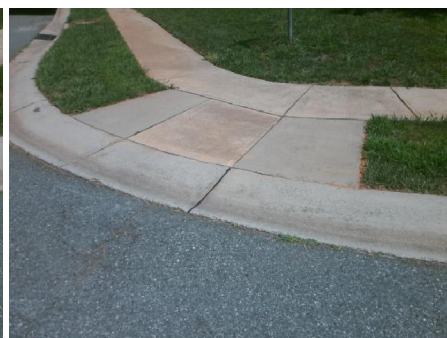
| Compliance | Description | Data | Compliance | Description | Data |
|---|---|---|---|---|---|
| | | | Yes | Surface Condition? (G/P) | Good |
