Access Compliance Report

Public Rights-of-Way

(Curb Ramps)

Intersection ID: 19024	Main Street: CAVENDISH_CT	Cross Street: PROVIDENCE_RD	Location: SE
ADA ID: 4BE28461FFCF	Ramp Type: PerpDiag	Initial Pass/Fail: Fail	Overall Compliance: No
		Severity Score: 8.75

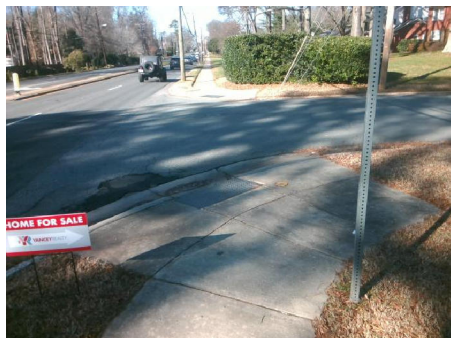
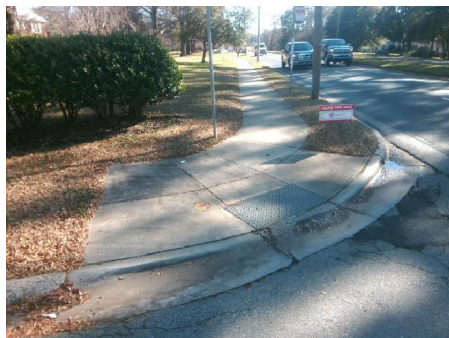
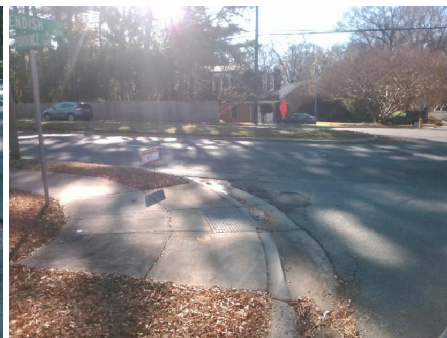
Not Found, R304.5.1

Compliance	Description	Data	Compliance	Description	Data
N/A	Ramp Length (in)	48.0	Yes	Ramp Slope (%)	6.7
No	Ramp Width (in)	39.0	Yes	Ramp XSlope (%)	0.0
N/A	Flare Type LT	N/A	N/A	Flare Type RT	N/A
N/A	Flare Slope LT (%)	N/A	N/A	Flare Slope RT (%)	N/A
N/A	Flare Traversable LT?	N/A	N/A	Flare Traversable RT?	N/A
N/A	Landing Length (in)	N/A	N/A	DWS Provided?	N/A
N/A	Landing Width (in)	N/A	N/A	DWS Contrast?	N/A
N/A	Landing Slope (%)	N/A	N/A	DWS Length (in)	N/A
N/A	Landing X Slope (%)	N/A	N/A	DWS Full Width?	N/A
N/A	Landing Curb? (Y/N)	N/A	N/A	DWS Offset (in)	N/A
N/A	Shared Landing?	N/A			
N/A	Gutter Ponding?	N/A	N/A	Gutter Slope (%)	N/A
N/A	Gutter Lip Ht (in)	N/A	N/A	Gutter X Slope (%)	N/A
N/A	Painted X Walk1?	No	N/A	Painted X Walk2?	No
	X Walk 1 Direction	To NW		X Walk 2 Direction	To SW
N/A	X Walk 1 Width (in)	N/A	N/A	X Walk 2 Width (in)	N/A
	X Walk 1 Slope (%)	5.3		X Walk 2 Slope (%)	3.0
	X Walk 1 X Slope (%)	1.1		X Walk 2 X Slope (%)	4.3

N/A	Ramp inside XWalk1?	N/A	N/A	Ramp inside XWalk2?	N/A
	Road Slope (%)	0.5	N/A	Clear Space?	N/A
	Road X Slope (%)	6.7	N/A	Clear Space to XWalk (in)	N/A
N/A	Any Obstructions?	N/A	N/A	Storm Grate/Utility Hazard?	N/A
	Obstruction Type			Storm Grate/Utility Type	
		N/A			N/A
			Yes	Surface Condition? (G/P)	Good

Remove & Replace Curb Ramp With Two New Directional Ramps or Equivalent.
