Access Compliance Report

Public Rights-of-Way

(Curb Ramps)

Intersection ID: 15102	Main Street: QUEENS_RD	Cross Street: E_MOREHEAD_ST	Location: E
ADA ID: 4BF8BDC2A113	Ramp Type: PerpDiag	Initial Pass/Fail: Fail	Overall Compliance: No
			Severity Score: 43.75

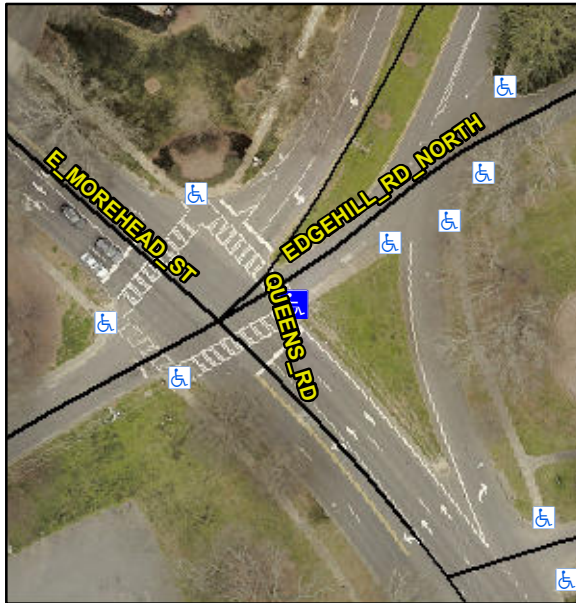
Not Found, R304.5.1, R304.2.2

Compliance	Description	Data	Compliance	Description	Data
N/A	Ramp Length (in)	75.0	No	Ramp Slope (%)	12.7
No	Ramp Width (in)	34.0	Yes	Ramp XSlope (%)	2.4
N/A	Flare Type LT	N/A	N/A	Flare Type RT	N/A
N/A	Flare Slope LT (%)	N/A	N/A	Flare Slope RT (%)	N/A
N/A	Flare Traversable LT?	N/A	N/A	Flare Traversable RT?	N/A
N/A	Landing Length (in)	N/A	N/A	DWS Provided?	N/A
N/A	Landing Width (in)	N/A	N/A	DWS Contrast?	N/A
N/A	Landing Slope (%)	N/A	N/A	DWS Length (in)	N/A
N/A	Landing X Slope (%)	N/A	N/A	DWS Full Width?	N/A
N/A	Landing Curb? (Y/N)	N/A	N/A	DWS Offset (in)	N/A
N/A	Shared Landing?	N/A			
N/A	Gutter Ponding?	N/A	N/A	Gutter Slope (%)	N/A
N/A	Gutter Lip Ht (in)	N/A	N/A	Gutter X Slope (%)	N/A
N/A	Painted X Walk1?	Yes	N/A	Painted X Walk2?	Yes
	X Walk 1 Direction	To NW		X Walk 2 Direction	To SW
N/A	X Walk 1 Width (in)	108.0	N/A	X Walk 2 Width (in)	108.0
	X Walk 1 Slope (%)	2.2		X Walk 2 Slope (%)	3.2
	X Walk 1 X Slope (%)	5.0		X Walk 2 X Slope (%)	2.9

N/A	Ramp inside XWalk1?	Yes	N/A	Ramp inside XWalk2?	Yes
	Road Slope (%)	6.5	N/A	Clear Space?	N/A
	Road X Slope (%)	2.5	N/A	Clear Space to XWalk (in)	N/A
N/A	Any Obstructions?	N/A	N/A	Storm Grate/Utility Hazard?	N/A
	Obstruction Type			Storm Grate/Utility Type	
		N/A			N/A
		Yes		Surface Condition? (G/P)	Good

Remove & Replace Curb Ramp With Two New Directional Ramps or Equivalent.
