# Access Compliance Report

## Public Rights-of-Way

### (Curb Ramps)

Intersection ID: N/A	Main Street: COPPER_WY	Cross Street: N/A	Location: SE
ADA ID: 4BF9EA19C261	Ramp Type: Perp	Initial Pass/Fail: Fail	Overall Compliance: No
Codes/Mitigation Info/Possible Solution		Field Measurements/Component Compliance	
Severity Score: 1.25

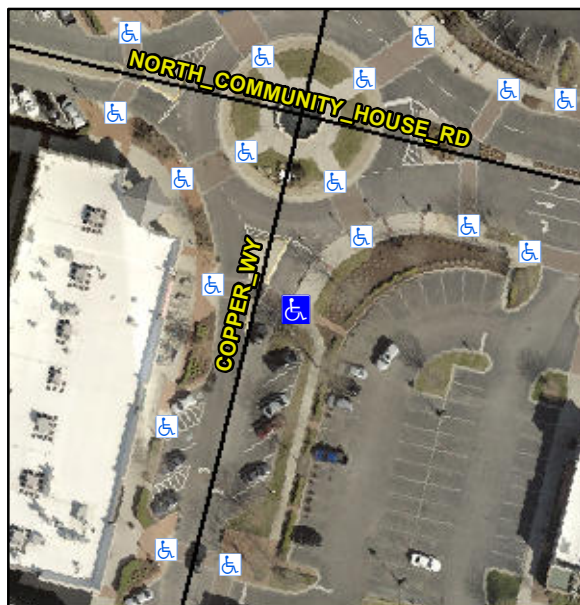
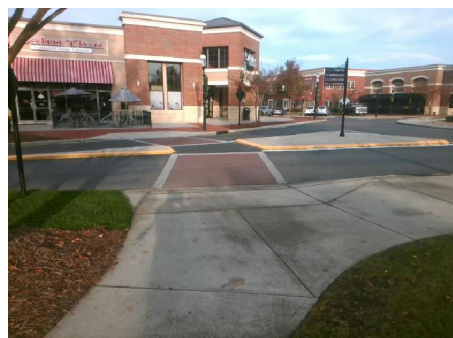
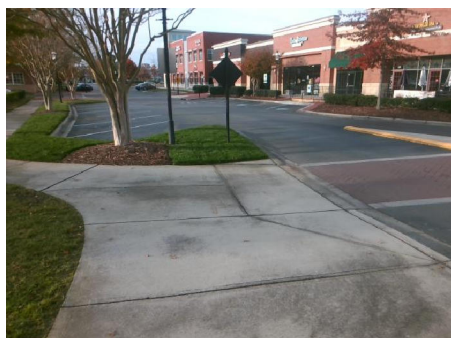
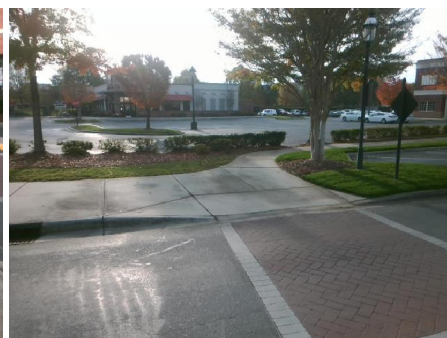
Compliance	Description	Data	Compliance	Description	Data
N/A	Ramp Length (in)	142.0	Yes	Ramp Slope (%)	6.6
Yes	Ramp Width (in)	113.0	No	Ramp XSlope (%)	3.6
N/A	Flare Type LT	N/A	N/A	Flare Type RT	N/A
N/A	Flare Slope LT (%)	N/A	N/A	Flare Slope RT (%)	N/A
N/A	Flare Traversable LT?	N/A	N/A	Flare Traversable RT?	N/A
N/A	Landing Length (in)	N/A	N/A	DWS Provided?	N/A
N/A	Landing Width (in)	N/A	N/A	DWS Contrast?	N/A
N/A	Landing Slope (%)	N/A	N/A	DWS Length (in)	N/A
N/A	Landing X Slope (%)	N/A	N/A	DWS Full Width?	N/A
N/A	Landing Curb? (Y/N)	N/A	N/A	DWS Offset (in)	N/A
N/A	Shared Landing?	N/A			
N/A	Gutter Ponding?	N/A	N/A	Gutter Slope (%)	N/A
N/A	Gutter Lip Ht (in)	N/A	N/A	Gutter X Slope (%)	N/A
N/A	Painted X Walk1?	Yes	N/A	Painted X Walk2?	N/A
	X Walk 1 Direction	To W		X Walk 2 Direction	N/A
N/A	X Walk 1 Width (in)	103.0	N/A	X Walk 2 Width (in)	N/A
	X Walk 1 Slope (%)	5.7		X Walk 2 Slope (%)	N/A
	X Walk 1 X Slope (%)	0.2		X Walk 2 X Slope (%)	N/A

N/A	Ramp inside XWalk1?	Yes	N/A	Ramp inside XWalk2?	N/A
	Road Slope (%)	N/A	N/A	Clear Space?	N/A
	Road X Slope (%)	N/A	N/A	Clear Space to XWalk (in)	N/A
N/A	Any Obstructions?	N/A	N/A	Storm Grate/Utility Hazard?	N/A
	Obstruction Type			Storm Grate/Utility Type	
		N/A			N/A
		Yes		Surface Condition? (G/P)	Good

Possible Solutions:

**Remove & Replace Entire Ramp.**

**R304.5.3**
