## **Access Compliance Report Public Rights-of-Way** (Curb Ramps)

Intersection ID: 13036 Main Street: CHATHAM AV **Cross Street: ROLAND ST** Location: SW Initial Pass/Fail: Fail **Overall Compliance: No Severity Score: ADA ID: 4C04BFC56E05** Ramp Type: Perp 8.75

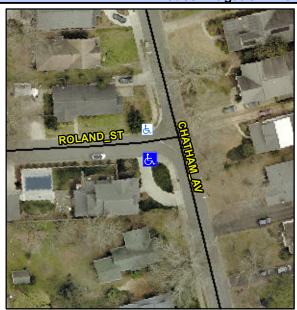
**ROLAND ST** Street 1 Name Stop Condition-Street 2 StopSign Street 2 Name N/A Stop Condition-Street 1 N/A Possible Solutions: Compliance Description N/A Remove & Replace Entire Ramp. No N/A N/A N/A N/A Surveyor Notes: N/A N/A N/A N/A

N/A
				N/A
PROW/ADA:				N/A
Not Found,	R304.5.1			N/A
				N/A
				N/A
				N/A
Total Cost:		\$	1850.00	N/A
