Access Compliance Report

Public Rights-of-Way

(Curb Ramps)

Intersection ID: 21514	Main Street: E_ARROWOOD_RD	Cross Street: NATIONS_FORD_RD	Location: SE
ADA ID: 4C0D3E8AB30F	Ramp Type: Perp	Initial Pass/Fail: Fail	Overall Compliance: No
Severity Score: 13.75			
Codes/Mitigation Info/Possible Solution		Field Measurements/Component Compliance

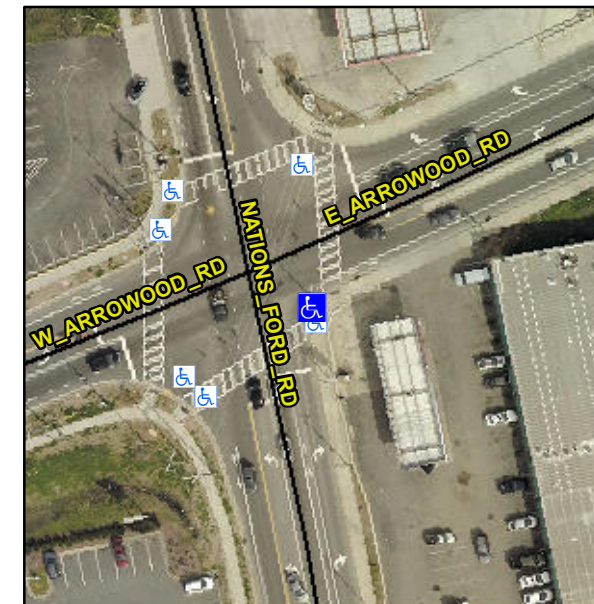
Not Found, R304.2.2

Compliance	Description	Data	Compliance	Description	Data
N/A	Ramp Length (in)	41.0	No	Ramp Slope (%)	9.9
Yes	Ramp Width (in)	59.0	Yes	Ramp XSlope (%)	2.6
N/A	Flare Type LT	N/A	N/A	Flare Type RT	N/A
N/A	Flare Slope LT (%)	N/A	N/A	Flare Slope RT (%)	N/A
N/A	Flare Traversable LT?	N/A	N/A	Flare Traversable RT?	N/A
N/A	Landing Length (in)	N/A	N/A	DWS Provided?	N/A
N/A	Landing Width (in)	N/A	N/A	DWS Contrast?	N/A
N/A	Landing Slope (%)	N/A	N/A	DWS Length (in)	N/A
N/A	Landing X Slope (%)	N/A	N/A	DWS Full Width?	N/A
N/A	Landing Curb? (Y/N)	N/A	N/A	DWS Offset (in)	N/A
N/A	Shared Landing?	N/A			
N/A	Gutter Ponding?	N/A	N/A	Gutter Slope (%)	N/A
N/A	Gutter Lip Ht (in)	N/A	N/A	Gutter X Slope (%)	N/A
N/A	Painted X Walk1?	Yes	N/A	Painted X Walk2?	N/A
	X Walk 1 Direction	To N		X Walk 2 Direction	N/A
N/A	X Walk 1 Width (in)	116.0	N/A	X Walk 2 Width (in)	N/A
	X Walk 1 Slope (%)	2.8		X Walk 2 Slope (%)	N/A
	X Walk 1 X Slope (%)	3.6		X Walk 2 X Slope (%)	N/A

N/A	Ramp inside XWalk1?	Yes	N/A	Ramp inside XWalk2?	N/A
	Road Slope (%)	N/A	N/A	Clear Space?	N/A
	Road X Slope (%)	N/A	N/A	Clear Space to XWalk (in)	N/A
N/A	Any Obstructions?	N/A	N/A	Storm Grate/Utility Hazard?	N/A
	Obstruction Type			Storm Grate/Utility Type	
		N/A			N/A
		Yes		Surface Condition? (G/P)	Good

Remove & Replace Entire Ramp.
