# Access Compliance Report

## Public Rights-of-Way

### (Curb Ramps)

Intersection ID: 50580	Main Street: LONGSTRAW_RD	Cross Street: PAPER_TREE_RD	Location: NE
ADA ID: 4C105A1A3624	Ramp Type: Perp	Initial Pass/Fail: Fail	Overall Compliance: No
Severity Score: 13.75			
Codes/Mitigation Info/Possible Solution		Field Measurements/Component Compliance

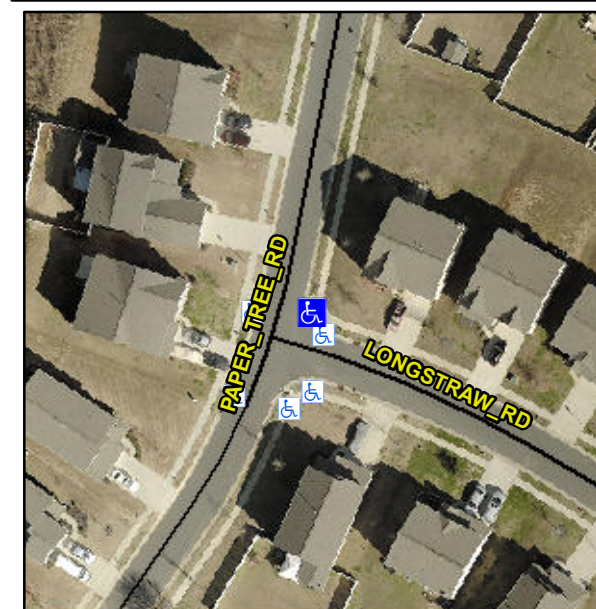
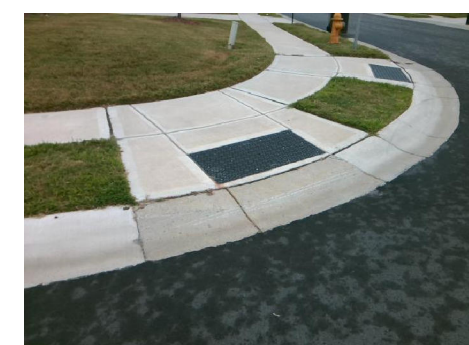
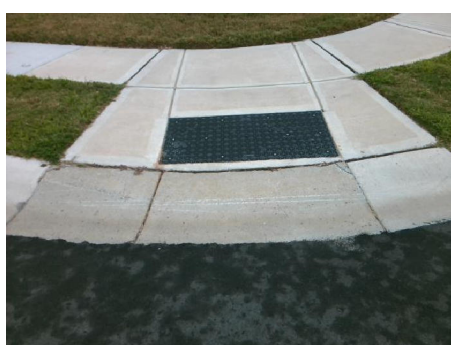
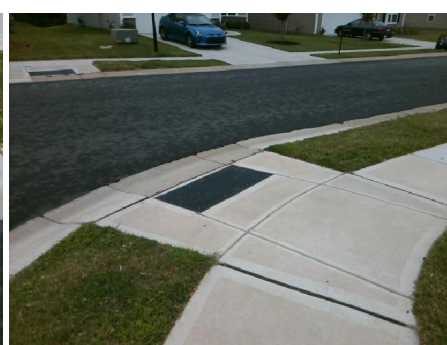
**Not Found, R304.2.2, R304.5.3**

Compliance	Description	Data	Compliance	Description	Data
N/A	Ramp Length (in)	48.0	No	Ramp Slope (%)	11.6
Yes	Ramp Width (in)	48.0	No	Ramp XSlope (%)	4.1
N/A	Flare Type LT	N/A	N/A	Flare Type RT	N/A
N/A	Flare Slope LT (%)	N/A	N/A	Flare Slope RT (%)	N/A
N/A	Flare Traversable LT?	N/A	N/A	Flare Traversable RT?	N/A
N/A	Landing Length (in)	N/A	N/A	DWS Provided?	N/A
N/A	Landing Width (in)	N/A	N/A	DWS Contrast?	N/A
N/A	Landing Slope (%)	N/A	N/A	DWS Length (in)	N/A
N/A	Landing X Slope (%)	N/A	N/A	DWS Full Width?	N/A
N/A	Landing Curb? (Y/N)	N/A	N/A	DWS Offset (in)	N/A
N/A	Shared Landing?	N/A			
N/A	Gutter Ponding?	N/A	N/A	Gutter Slope (%)	N/A
N/A	Gutter Lip Ht (in)	N/A	N/A	Gutter X Slope (%)	N/A
N/A	Painted X Walk1?	No	N/A	Painted X Walk2?	N/A
	X Walk 1 Direction	To W		X Walk 2 Direction	N/A
N/A	X Walk 1 Width (in)	N/A	N/A	X Walk 2 Width (in)	N/A
	X Walk 1 Slope (%)	0.5		X Walk 2 Slope (%)	N/A
	X Walk 1 X Slope (%)	2.0		X Walk 2 X Slope (%)	N/A

N/A	Ramp inside XWalk1?	N/A	N/A	Ramp inside XWalk2?	N/A
	Road Slope (%)	N/A	N/A	Clear Space?	N/A
	Road X Slope (%)	N/A	N/A	Clear Space to XWalk (in)	N/A
N/A	Any Obstructions?	N/A	N/A	Storm Grate/Utility Hazard?	N/A
	Obstruction Type			Storm Grate/Utility Type	
		N/A			N/A
		Yes		Surface Condition? (G/P)	Good

**Remove & Replace Entire Ramp.**

Total Cost: \$ 1850.00
