Access Compliance Report

Public Rights-of-Way

(Curb Ramps)

Intersection ID: 11824	Main Street: W_8TH_ST	Cross Street: N_CHURCH_ST	Location: N
ADA ID: 4C1AE6046AD1	Ramp Type: Perp	Initial Pass/Fail: Fail	Overall Compliance: No
		Severity Score: 12.5

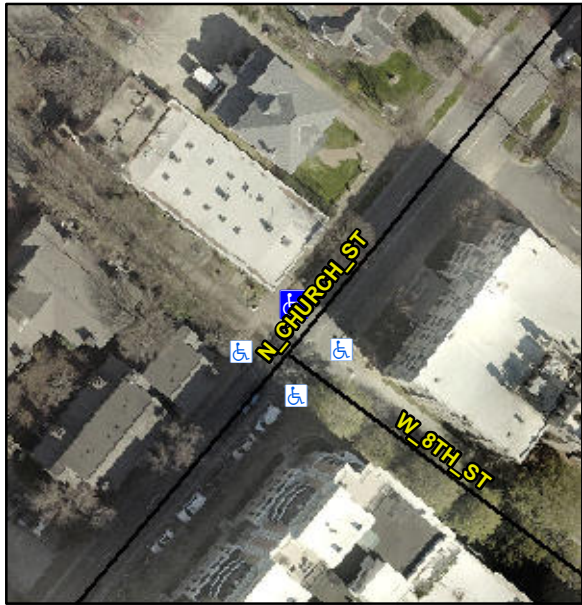
Possible Solutions:		Compliance	Description	Data	Compliance	Description	Data
	Remove & Replace Entire Ramp.		N/A	Ramp Length (in)	61.0	No	Ramp Slope (%)	11.6
			Yes	Ramp Width (in)	48.0	Yes	Ramp XSlope (%)	1.5
			N/A	Flare Type LT	N/A	N/A	Flare Type RT	N/A
			N/A	Flare Slope LT (%)	N/A	N/A	Flare Slope RT (%)	N/A
			N/A	Flare Traversable LT?	N/A	N/A	Flare Traversable RT?	N/A
			N/A	Landing Length (in)	N/A	N/A	DWS Provided?	N/A
			N/A	Landing Width (in)	N/A	N/A	DWS Contrast?	N/A
			N/A	Landing Slope (%)	N/A	N/A	DWS Length (in)	N/A
			N/A	Landing X Slope (%)	N/A	N/A	DWS Full Width?	N/A
Surveyor Notes:		N/A	N/A	Landing Curb? (Y/N)	N/A	N/A	DWS Offset (in)	N/A
PROW/ADA:		Not Found, R304.2.2	N/A	Shared Landing?	N/A			
			N/A	Gutter Ponding?	N/A	N/A	Gutter Slope (%)	N/A
			N/A	Gutter Lip Ht (in)	N/A	N/A	Gutter X Slope (%)	N/A

N/A	Painted X Walk1?	No	N/A	Painted X Walk2?	N/A
				X Walk 1 Direction	To SE		X Walk 2 Direction	N/A
			N/A	X Walk 1 Width (in)	N/A	N/A	X Walk 2 Width (in)	N/A
				X Walk 1 Slope (%)	8.2		X Walk 2 Slope (%)	N/A
				X Walk 1 X Slope (%)	12.5		X Walk 2 X Slope (%)	N/A
			N/A	Ramp inside XWalk1?	N/A	N/A	Ramp inside XWalk2?	N/A
				Road Slope (%)	N/A	N/A	Clear Space?	N/A
				Road X Slope (%)	N/A	N/A	Clear Space to XWalk (in)	N/A
			N/A	Any Obstructions?	N/A	N/A	Storm Grate/Utility Hazard?	N/A
				Obstruction Type			Storm Grate/Utility Type	
					N/A			N/A
						Yes	Surface Condition? (G/P)	Good
Street 1 Name		N CHURCH ST						
Stop Condition-Street 2		None						
Street 2 Name		N/A						
Stop Condition-Street 1		N/A						
Total Cost:		\$ 1850.00
