Access Compliance Report

Public Rights-of-Way

(Curb Ramps)

Intersection ID: 49312	Main Street: MISTY_EVE_LN	Cross Street: BROOKE_NICOLE_PL	Location: W
ADA ID: 4C1B97F01A39	Ramp Type: PerpDiag	Initial Pass/Fail: Fail	Overall Compliance: No
		Severity Score: 50

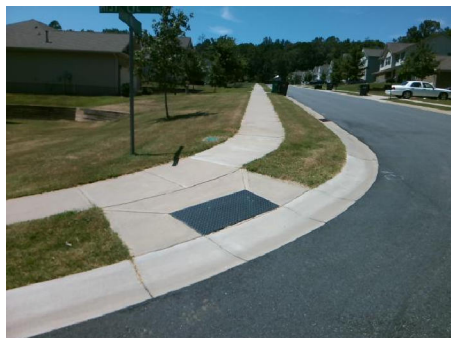
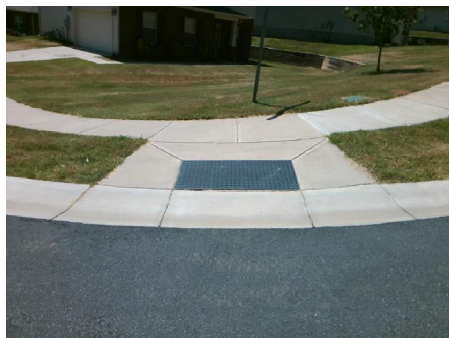
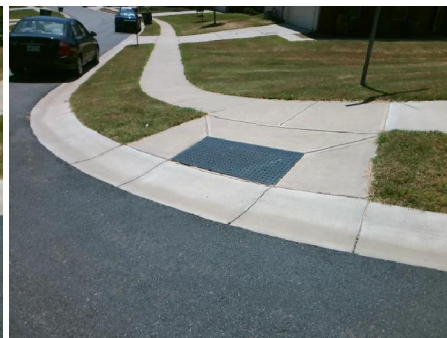
Compliance	Description	Data	Compliance	Description	Data
N/A	Ramp Length (in)	47.5	No	Ramp Slope (%)	13.5
Yes	Ramp Width (in)	48.0	No	Ramp XSlope (%)	12.7
N/A	Flare Type LT	N/A	N/A	Flare Type RT	N/A
N/A	Flare Slope LT (%)	N/A	N/A	Flare Slope RT (%)	N/A
N/A	Flare Traversable LT?	N/A	N/A	Flare Traversable RT?	N/A
N/A	Landing Length (in)	N/A	N/A	DWS Provided?	N/A
N/A	Landing Width (in)	N/A	N/A	DWS Contrast?	N/A
N/A	Landing Slope (%)	N/A	N/A	DWS Length (in)	N/A
N/A	Landing X Slope (%)	N/A	N/A	DWS Full Width?	N/A
N/A	Landing Curb? (Y/N)	N/A	N/A	DWS Offset (in)	N/A
N/A	Shared Landing?	N/A			
N/A	Gutter Ponding?	N/A	N/A	Gutter Slope (%)	N/A
N/A	Gutter Lip Ht (in)	0.5	N/A	Gutter X Slope (%)	N/A
N/A	Painted X Walk1?	No	N/A	Painted X Walk2?	No
	X Walk 1 Direction	To S		X Walk 2 Direction	To N
N/A	X Walk 1 Width (in)	N/A	N/A	X Walk 2 Width (in)	N/A
	X Walk 1 Slope (%)	7.8		X Walk 2 Slope (%)	8.0
	X Walk 1 X Slope (%)	8.1		X Walk 2 X Slope (%)	8.8

N/A	Ramp inside XWalk1?	N/A	N/A	Ramp inside XWalk2?	N/A
	Road Slope (%)	9.7	N/A	Clear Space?	N/A
	Road X Slope (%)	0.4	N/A	Clear Space to XWalk (in)	N/A
N/A	Any Obstructions?	N/A	N/A	Storm Grate/Utility Hazard?	N/A
	Obstruction Type			Storm Grate/Utility Type	
		N/A			N/A
			Yes	Surface Condition? (G/P)	Good

Possible Solutions:

Remove & Replace Curb Ramp With Two New Directional Ramps or Equivalent.
