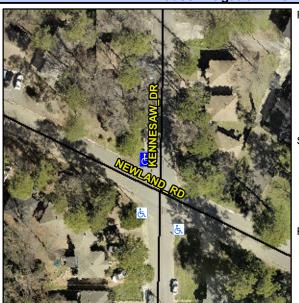
Intersection ID: 8237Main Street: KENNESAW_DRCross Street: NEWLAND_RDLocation: NWADA ID: 4C2170A99D09Ramp Type: PerpInitial Pass/Fail: Fail Overall Compliance: No Severity Score: 12.5

Field Measurements/Component Compliance								
Comp	liance Description	Data	Compl	iance	Description	Data		
N/A	Ramp Length (in)	25.5	No	Ramp	Slope (%)	9.8		
Yes	Ramp Width (in)	48.0	Yes	Ramp	XSlope (%)	1.3		
N/A	Flare Type LT	N/A	N/A	Flare	Type RT	N/A		
N/A	Flare Slope LT (%)	N/A	N/A	Flare	Slope RT (%)	N/A		
N/A	Flare Traversable LT?	N/A	N/A	Flare	Traversable RT?	N/A		
N/A	Landing Length (in)	N/A	N/A	DWS	Provided?	N/A		
N/A	Landing Width (in)	N/A	N/A	DWS	Contrast?	N/A		
N/A	Landing Slope (%)	N/A	N/A	DWS	Length (in)	N/A		
N/A	Landing X Slope (%)	N/A	N/A	DWS	Full Width?	N/A		
N/A	Landing Curb? (Y/N)	N/A	N/A	DWS	Offset (in)	N/A		
N/A	Shared Landing?	N/A						
N/A	Gutter Ponding?	N/A	N/A	Gutte	r Slope (%)	N/A		
N/A	Gutter Lip Ht (in)	N/A	N/A	Gutte	r X Slope (%)	N/A		
N/A	Painted X Walk1?	No	N/A	Paint	ed X Walk2?	N/A		
	X Walk 1 Direction	To S		X Wa	lk 2 Direction	N/A		
N/A	X Walk 1 Width (in)	N/A	N/A	X Wa	lk 2 Width (in)	N/A

X Walk 1 Slope (%)	0.7		X Wa	lk 2 Slope (%)	N/A		
	X Walk 1 X Slope (%)	3.3		X Wa	lk 2 X Slope (%)	N/A		
N/A	Ramp inside XWalk1?	N/A	N/A	Ramp	inside XWalk2?	N/A		
	Road Slope (%)	N/A	N/A	Clear	Space?	N/A		
	Road X Slope (%)	N/A	N/A	Clear	Space to XWalk (in)	N/A		
N/A	Any Obstructions?	N/A	N/A	Storm	n Grate/Utility Hazard?	N/A		
	Obstruction Type			Storm	n Grate/Utility Type			
		N/A				N/A		
			Yes	Surfa	ce Condition? (G/P)	Good

Possible Solutions:	Con
Remove & Replace Entire Ramp.	N/A
•	Yes
	N/A
	N/A
	N/A
	N/A
Surveyor Notes:	N/A
N/A	N/A
	N/A
	N/A
	N/A
PROW/ADA:	N/A
Not Found, R304.2.2	N/A
	N/A
	N/A
	N/A
