Access Compliance Report

Public Rights-of-Way

(Curb Ramps)

Intersection ID: 25829	Main Street: GREYSON RIDGE DR	Cross Street: HIGH RIDGE RD	Location: NE
ADA ID: 4C2F858E096D	Ramp Type: Perp	Initial Pass/Fail: Fail	Overall Compliance: No
Severity Score: 21.25			
Codes/Mitigation Info/Possible Solution		Field Measurements/Component Compliance

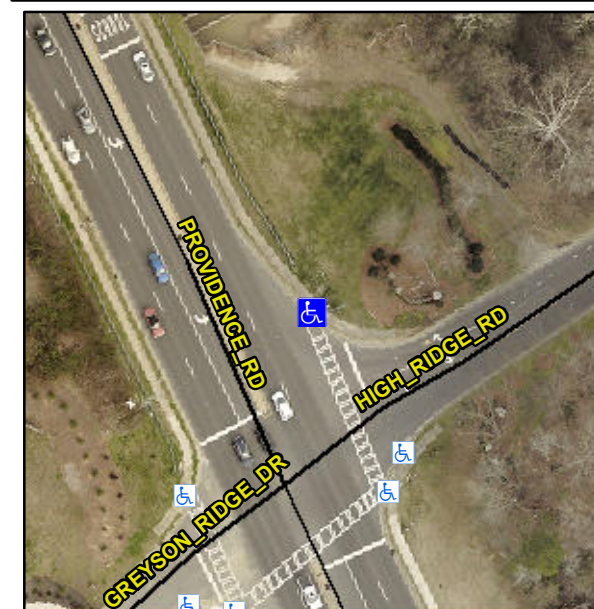
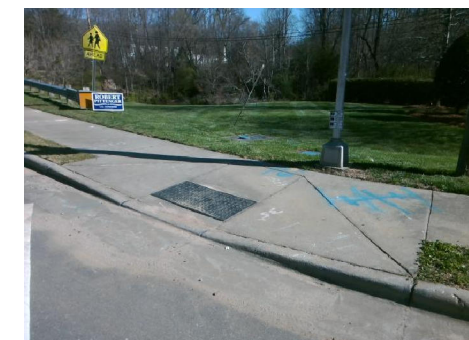
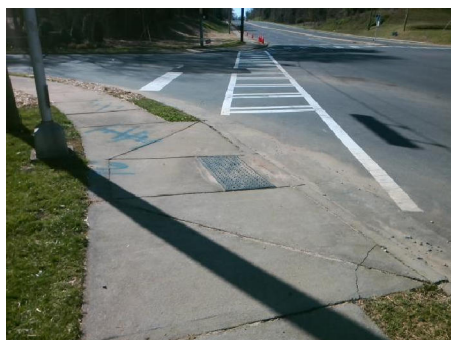
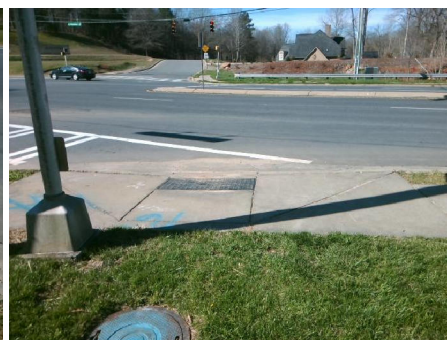
Not Found, R304.5.1, R304.2.2

Compliance	Description	Data	Compliance	Description	Data
N/A	Ramp Length (in)	73.0	No	Ramp Slope (%)	8.5
No	Ramp Width (in)	47.0	Yes	Ramp XSlope (%)	1.5
N/A	Flare Type LT	N/A	N/A	Flare Type RT	N/A
N/A	Flare Slope LT (%)	N/A	N/A	Flare Slope RT (%)	N/A
N/A	Flare Traversable LT?	N/A	N/A	Flare Traversable RT?	N/A
N/A	Landing Length (in)	N/A	N/A	DWS Provided?	N/A
N/A	Landing Width (in)	N/A	N/A	DWS Contrast?	N/A
N/A	Landing Slope (%)	N/A	N/A	DWS Length (in)	N/A
N/A	Landing X Slope (%)	N/A	N/A	DWS Full Width?	N/A
N/A	Landing Curb? (Y/N)	N/A	N/A	DWS Offset (in)	N/A
N/A	Shared Landing?	N/A			
N/A	Gutter Ponding?	N/A	N/A	Gutter Slope (%)	N/A
N/A	Gutter Lip Ht (in)	N/A	N/A	Gutter X Slope (%)	N/A
N/A	Painted X Walk1?	Yes	N/A	Painted X Walk2?	N/A
	X Walk 1 Direction	To S		X Walk 2 Direction	N/A
N/A	X Walk 1 Width (in)	75.0	N/A	X Walk 2 Width (in)	N/A
	X Walk 1 Slope (%)	2.2		X Walk 2 Slope (%)	N/A
	X Walk 1 X Slope (%)	3.2		X Walk 2 X Slope (%)	N/A

N/A	Ramp inside XWalk1?	Yes	N/A	Ramp inside XWalk2?	N/A
	Road Slope (%)	N/A	N/A	Clear Space?	N/A
	Road X Slope (%)	N/A	N/A	Clear Space to XWalk (in)	N/A
N/A	Any Obstructions?	N/A	N/A	Storm Grate/Utility Hazard?	N/A
	Obstruction Type			Storm Grate/Utility Type	
		N/A			N/A
		Yes		Surface Condition? (G/P)	Good

Possible Solutions:

Remove & Replace Entire Ramp.
