Access Compliance Report

Public Rights-of-Way

(Curb Ramps)

Intersection ID: 48567	Main Street: CROSSVINE_LN	Cross Street: BRAMBLE_RIDGE_CT	Location: SW
ADA ID: 4C475A58556E	Ramp Type: PerpDiag	Initial Pass/Fail: Pass	Overall Compliance: No
		Severity Score: 7.5

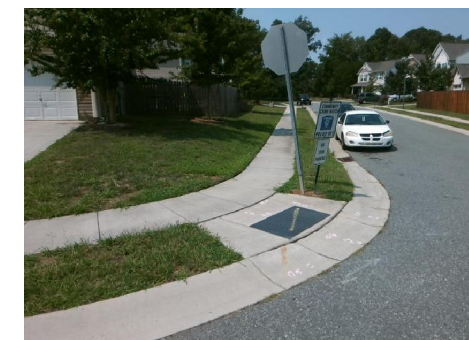
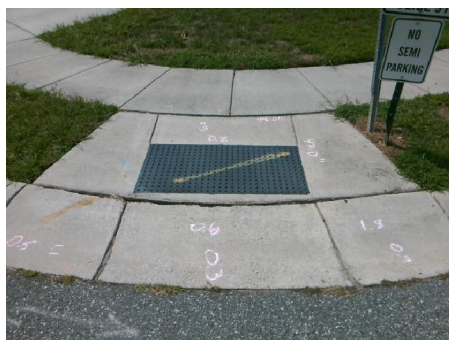
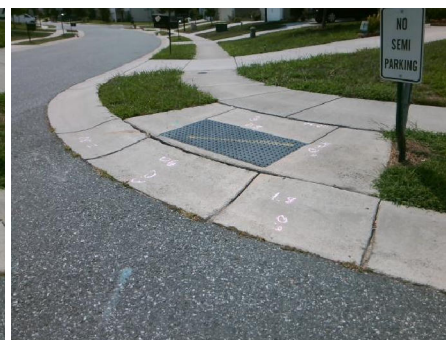
Not Found, R305.2, R302.7.2

Compliance	Description	Data	Compliance	Description	Data
N/A	Ramp Length (in)	47.0	Yes	Ramp Slope (%)	6.0
Yes	Ramp Width (in)	48.0	Yes	Ramp XSlope (%)	0.8
N/A	Flare Type LT	Sloped	N/A	Flare Type RT	N/A
N/A	Flare Slope LT (%)	1.2	N/A	Flare Slope RT (%)	1.3
N/A	Flare Traversable LT?	No	N/A	Flare Traversable RT?	No
Yes	Landing Length (in)	48.0	Yes	DWS Provided?	Yes
Yes	Landing Width (in)	61.0	Yes	DWS Contrast?	Yes
Yes	Landing Slope (%)	1.5	Yes	DWS Length (in)	24.5
Yes	Landing X Slope (%)	1.4	Yes	DWS Full Width?	Yes
N/A	Landing Curb? (Y/N)	No	No	DWS Offset (in)	5.0
N/A	Shared Landing?	No			
Yes	Gutter Ponding?	No	Yes	Gutter Slope (%)	2.5
No	Gutter Lip Ht (in)	0.5	Yes	Gutter X Slope (%)	0.9
N/A	Painted X Walk1?	No	N/A	Painted X Walk2?	No
	X Walk 1 Direction	To E		X Walk 2 Direction	To N
N/A	X Walk 1 Width (in)	N/A	N/A	X Walk 2 Width (in)	N/A
	X Walk 1 Slope (%)	1.1		X Walk 2 Slope (%)	0.9
	X Walk 1 X Slope (%)	0.5		X Walk 2 X Slope (%)	1.8

N/A	Ramp inside XWalk1?	N/A	N/A	Ramp inside XWalk2?	N/A
	Road Slope (%)	0.6	N/A	Clear Space?	Yes
	Road X Slope (%)	0.3	N/A	Clear Space to XWalk (in)	N/A
Yes	Any Obstructions?	No	Yes	Storm Grate/Utility Hazard?	No
	Obstruction Type			Storm Grate/Utility Type	
		N/A			N/A
			Yes	Surface Condition? (G/P)	Good

Remove & Replace Curb Ramp With Two New Directional Ramps or Equivalent.
