Access Compliance Report

Public Rights-of-Way

(Curb Ramps)

Intersection ID: 28698	Main Street: OLD_LITTLE_ROCK_RD	Cross Street: N/A	Location: SW
ADA ID: 4C4FC6D725C5	Ramp Type: BlendTrans1	Initial Pass/Fail: Fail	Overall Compliance: No
Severity Score: 8.75			
Codes/Mitigation Info/Possible Solution		Field Measurements/Component Compliance

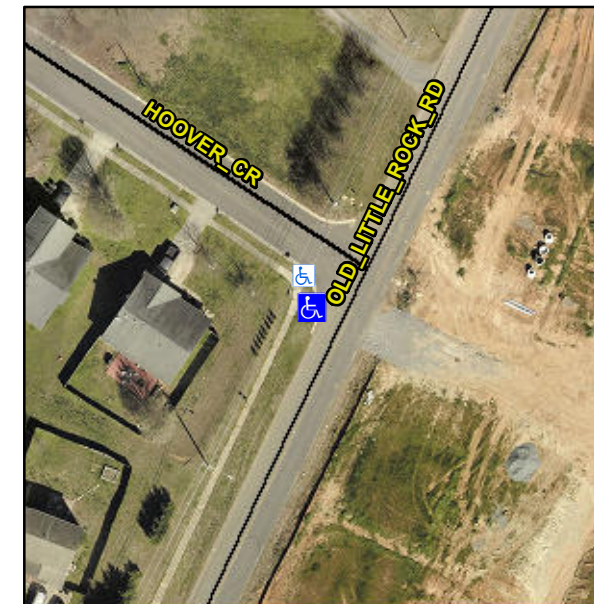
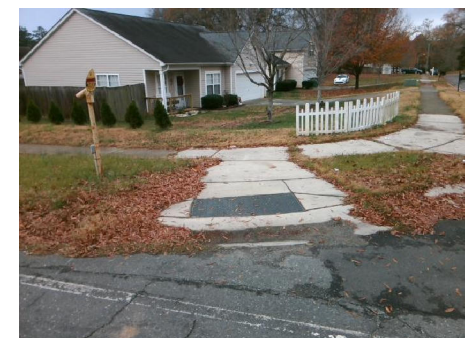
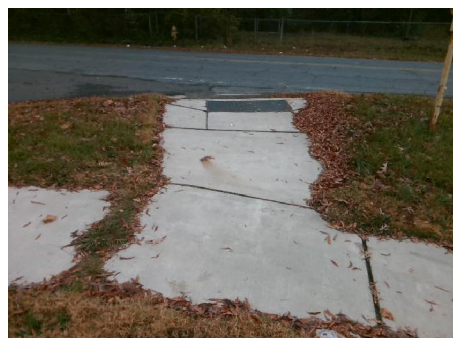
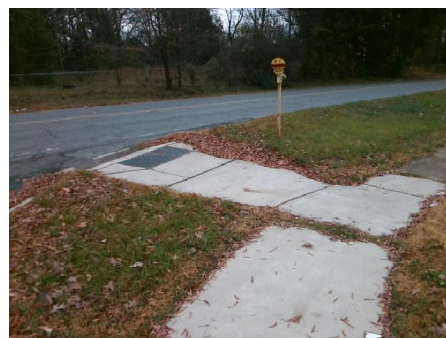
Not Found, R304.5.1

Compliance	Description	Data	Compliance	Description	Data
N/A	Ramp Length (in)	52.0	Yes	BlendTrans Slope (%)	3.8
No	Ramp Width (in)	47.5	Yes	BlendTrans XSlope (%)	1.8
N/A	Flare Type LT	N/A	N/A	Flare Type RT	N/A
N/A	Flare Slope LT (%)	N/A	N/A	Flare Slope RT (%)	N/A
N/A	Flare Traversable LT?	N/A	N/A	Flare Traversable RT?	N/A
N/A	Landing Length (in)	N/A	N/A	DWS Provided?	N/A
N/A	Landing Width (in)	N/A	N/A	DWS Contrast?	N/A
N/A	Landing Slope (%)	N/A	N/A	DWS Length (in)	N/A
N/A	Landing X Slope (%)	N/A	N/A	DWS Full Width?	N/A
N/A	Landing Curb? (Y/N)	N/A	N/A	DWS Offset (in)	N/A
N/A	Shared Landing?	N/A			
N/A	Gutter Ponding?	N/A	N/A	Gutter Slope (%)	N/A
N/A	Gutter Lip Ht (in)	N/A	N/A	Gutter X Slope (%)	N/A
N/A	Painted X Walk1?	No	N/A	Painted X Walk2?	N/A
	X Walk 1 Direction	To E		X Walk 2 Direction	N/A
	X Walk 1 Width (in)	N/A		X Walk 2 Width (in)	N/A
	X Walk 1 Slope (%)	3.6		X Walk 2 Slope (%)	N/A
	X Walk 1 X Slope (%)	0.1		X Walk 2 X Slope (%)	N/A

N/A	Ramp inside XWalk1?	N/A	N/A	Ramp inside XWalk2?	N/A
	Road Slope (%)	0.1		Clear Space?	N/A
	Road X Slope (%)	3.6	N/A	Clear Space to XWalk (in)	N/A
N/A	Any Obstructions?	N/A	N/A	Storm Grate/Utility Hazard?	N/A
	Obstruction Type			Storm Grate/Utility Type	
		N/A			N/A
			Yes	Surface Condition? (G/P)	Good
			No	Curb Slope (%)	11.4

Remove & Replace Curb Ramp With Two New Directional Ramps or Equivalent.
