Access Compliance Report

Public Rights-of-Way

(Curb Ramps)

Intersection ID: 10035708	Main Street: REDDMAN_RD	Cross Street: N/A	Location: SE
ADA ID: 4C5386DDE827	Ramp Type: PerpDiag	Initial Pass/Fail: Fail	Overall Compliance: No
		Severity Score: 12.5

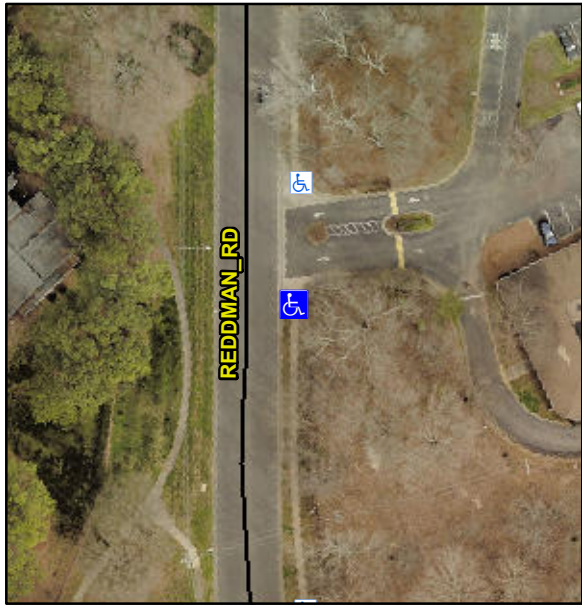
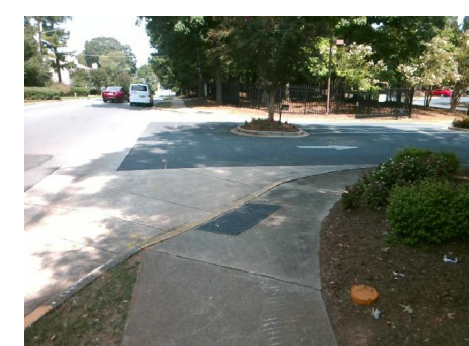
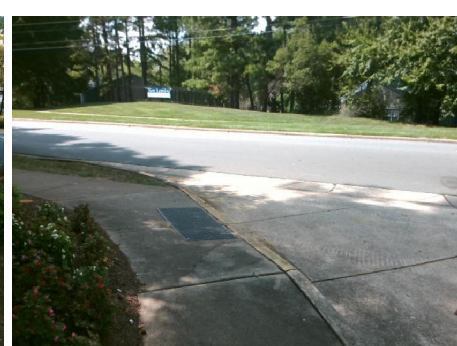
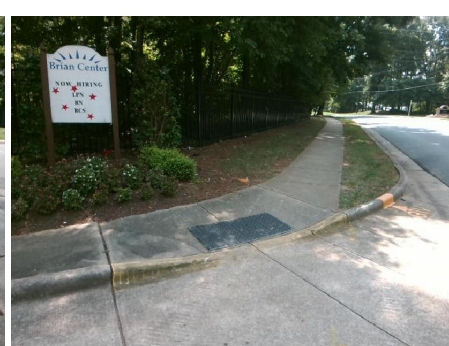
Possible Solutions:		Compliance	Description	Data	Compliance	Description	Data
	Remove & Replace Curb Ramp With Two New Directional Ramps or Equivalent.		N/A	Ramp Length (in)	60.0	No	Ramp Slope (%)	11.7
			Yes	Ramp Width (in)	48.0	Yes	Ramp XSlope (%)	0.4
			N/A	Flare Type LT	N/A	N/A	Flare Type RT	N/A
			N/A	Flare Slope LT (%)	N/A	N/A	Flare Slope RT (%)	N/A
			N/A	Flare Traversable LT?	N/A	N/A	Flare Traversable RT?	N/A
			N/A	Landing Length (in)	N/A	N/A	DWS Provided?	N/A
			N/A	Landing Width (in)	N/A	N/A	DWS Contrast?	N/A
			N/A	Landing Slope (%)	N/A	N/A	DWS Length (in)	N/A
			N/A	Landing X Slope (%)	N/A	N/A	DWS Full Width?	N/A
Surveyor Notes:		N/A	N/A	Landing Curb? (Y/N)	N/A	N/A	DWS Offset (in)	N/A
PROW/ADA:		Not Found, R304.2.2	N/A	Shared Landing?	N/A			
			N/A	Gutter Ponding?	N/A	N/A	Gutter Slope (%)	N/A
			N/A	Gutter Lip Ht (in)	N/A	N/A	Gutter X Slope (%)	N/A

N/A	Painted X Walk1?	No	N/A	Painted X Walk2?	No
				X Walk 1 Direction	To N		X Walk 2 Direction	To W
			N/A	X Walk 1 Width (in)	N/A	N/A	X Walk 2 Width (in)	N/A
				X Walk 1 Slope (%)	3.5		X Walk 2 Slope (%)	5.5
				X Walk 1 X Slope (%)	2.3		X Walk 2 X Slope (%)	0.8
			N/A	Ramp inside XWalk1?	N/A	N/A	Ramp inside XWalk2?	N/A
				Road Slope (%)	3.1	N/A	Clear Space?	N/A
				Road X Slope (%)	0.1	N/A	Clear Space to XWalk (in)	N/A
			N/A	Any Obstructions?	N/A	N/A	Storm Grate/Utility Hazard?	N/A
				Obstruction Type			Storm Grate/Utility Type	
						N/A		N/A
						Yes	Surface Condition? (G/P)	Good
Total Cost:		\$ 3200.00						
Street 1 Name			ENTRANCE					
Stop Condition-Street 2			None					
Street 2 Name			REDDMAN RD					
Stop Condition-Street 1			None
