# Access Compliance Report

## Public Rights-of-Way

### (Curb Ramps)

Intersection ID: 50928	Main Street: GREAT_FUTURE_DR	Cross Street: MARVIN_RD	Location: SW
ADA ID: 4C54BD78DD79	Ramp Type: Perp	Initial Pass/Fail: Fail	Overall Compliance: No
Codes/Mitigation Info/Possible Solution		Field Measurements/Component Compliance	
Severity Score: 33.75

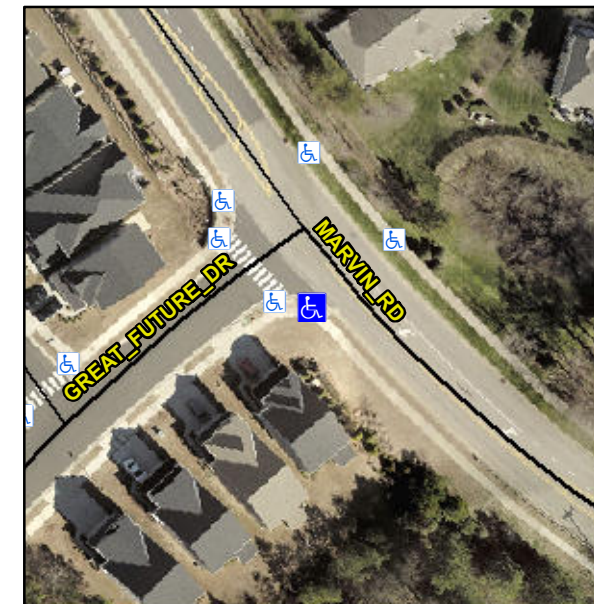
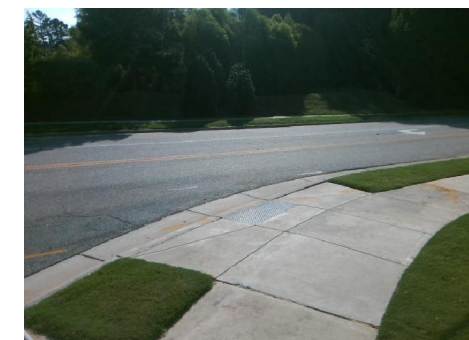
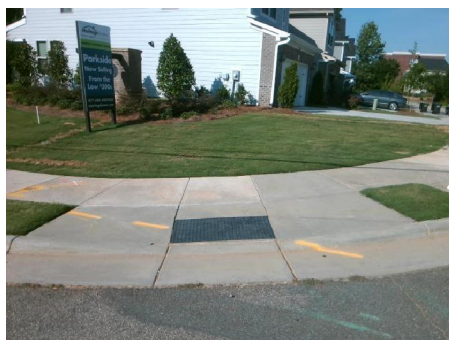
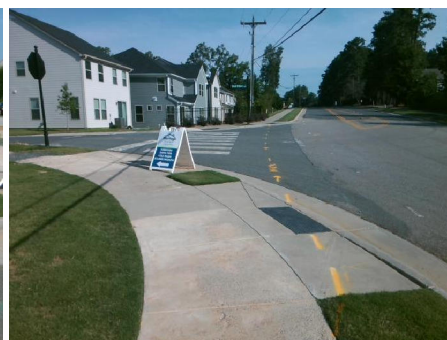
**Not Found, R304.5.1, R304.5.3**

Compliance	Description	Data	Compliance	Description	Data
N/A	Ramp Length (in)	46.0	Yes	Ramp Slope (%)	6.6
No	Ramp Width (in)	47.0	No	Ramp XSlope (%)	8.6
N/A	Flare Type LT	N/A	N/A	Flare Type RT	N/A
N/A	Flare Slope LT (%)	N/A	N/A	Flare Slope RT (%)	N/A
N/A	Flare Traversable LT?	N/A	N/A	Flare Traversable RT?	N/A
N/A	Landing Length (in)	N/A	N/A	DWS Provided?	N/A
N/A	Landing Width (in)	N/A	N/A	DWS Contrast?	N/A
N/A	Landing Slope (%)	N/A	N/A	DWS Length (in)	N/A
N/A	Landing X Slope (%)	N/A	N/A	DWS Full Width?	N/A
N/A	Landing Curb? (Y/N)	N/A	N/A	DWS Offset (in)	N/A
N/A	Shared Landing?	N/A			
N/A	Gutter Ponding?	N/A	N/A	Gutter Slope (%)	N/A
N/A	Gutter Lip Ht (in)	N/A	N/A	Gutter X Slope (%)	N/A
N/A	Painted X Walk1?	No	N/A	Painted X Walk2?	N/A
	X Walk 1 Direction	To NE		X Walk 2 Direction	N/A
N/A	X Walk 1 Width (in)	N/A	N/A	X Walk 2 Width (in)	N/A
	X Walk 1 Slope (%)	2.9		X Walk 2 Slope (%)	N/A
	X Walk 1 X Slope (%)	6.5		X Walk 2 X Slope (%)	N/A

N/A	Ramp inside XWalk1?	N/A	N/A	Ramp inside XWalk2?	N/A
	Road Slope (%)	N/A	N/A	Clear Space?	N/A
	Road X Slope (%)	N/A	N/A	Clear Space to XWalk (in)	N/A
N/A	Any Obstructions?	N/A	N/A	Storm Grate/Utility Hazard?	N/A
	Obstruction Type			Storm Grate/Utility Type	
		N/A			N/A
			Yes	Surface Condition? (G/P)	Good

**Remove & Replace Entire Ramp.**

Total Cost: \$ 1850.00
