Access Compliance Report

Public Rights-of-Way

(Curb Ramps)

Intersection ID: 6215	Main Street: IRISH_MOSS_LN	Cross Street: ALLEN_RD_SOUTH	Location: NE
ADA ID: 4C56D53E7A8A	Ramp Type: Directional1	Initial Pass/Fail: Fail	Overall Compliance: No
		Severity Score: 35

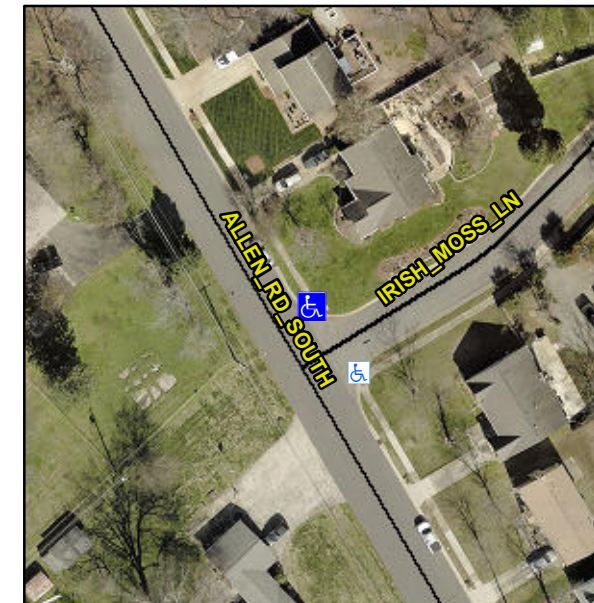
DWS DETACHED

R304.5.1, R304.2.2, R304.5.3

Compliance	Description	Data	Compliance	Description	Data
N/A	Ramp Length (in)	44.0	N/A	Grade Break?	N/A
No	Ramp Width (in)	40.0	N/A	Grade Break Slope (%)	0.0
No	Ramp Slope (%)	12.7	N/A	Grade Break XSlope (%)	0.0
No	Ramp XSlope (%)	4.5			
N/A	Flare Type LT	N/A	N/A	Flare Type RT	N/A
N/A	Flare Slope LT (%)	N/A	N/A	Flare Slope RT (%)	0.0
N/A	Flare Traversable LT?	N/A	N/A	Flare Traversable RT?	N/A
N/A	Landing Length (in)	0.0	N/A	DWS Provided?	N/A
N/A	Landing Width (in)	0.0	N/A	DWS Contrast?	N/A
N/A	Landing Slope (%)	0.0	N/A	DWS Length (in)	N/A
N/A	Landing X Slope (%)	0.0	N/A	DWS Full Width?	N/A
N/A	Landing Curb? (Y/N)	N/A	N/A	DWS Offset LT (in)	N/A
N/A	Shared Landing?	N/A	N/A	DWS Offset RT (in)	N/A
N/A	Gutter Ponding?	0.0	N/A	Gutter Slope (%)	N/A
N/A	Gutter Lip Ht (in)	0.0	N/A	Gutter X Slope (%)	N/A
N/A	Painted X Walk1?	No		Road Slope (%)	0.7
	X Walk 1 Direction	To SE		Road X Slope (%)	3.6
	X Walk 1 Width (in)	N/A		Clear Space?	N/A

X Walk 1 Slope (%)	0.7	N/A	Clear Space to XWalk (in)	N/A
	X Walk 1 X Slope (%)	3.6	N/A	Storm Grate/Utility Hazard?	N/A
N/A	Ramp inside XWalk1?	N/A		Storm Grate/Utility Type	
N/A	Any Obstructions?	N/A			N/A
	Obstruction Type		Yes	Surface Condition? (G/P)	Good
			N/A	Curb Slope (%)	N/A

Remove & Replace Entire Ramp.
