Access Compliance Report

Public Rights-of-Way

(Curb Ramps)

Intersection ID: 12527	Main Street: E_7TH_ST	Cross Street: N_DAVIDSON_ST	Location: W
ADA ID: 4C58678AB930	Ramp Type: PerpDiag	Initial Pass/Fail: Fail	Overall Compliance: No
Severity Score: 35			
Codes/Mitigation Info/Possible Solution		Field Measurements/Component Compliance

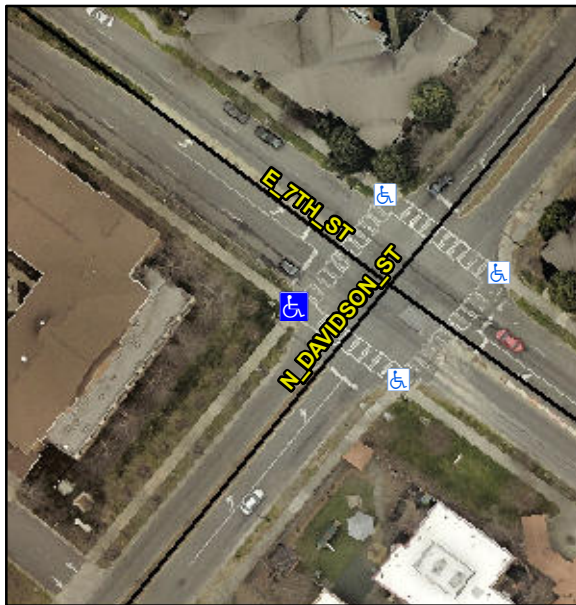
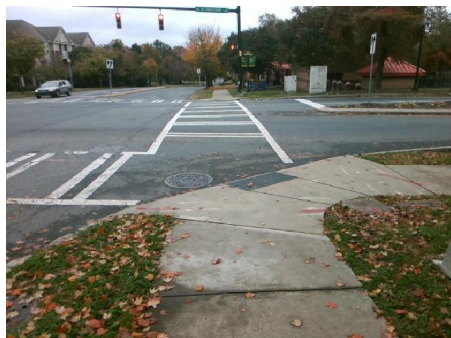
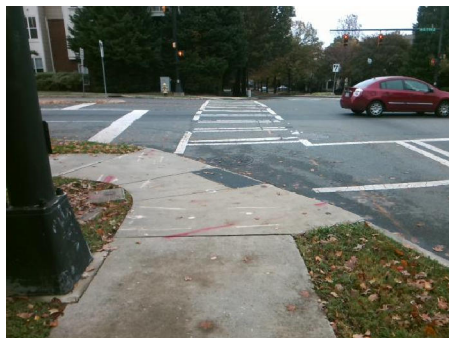
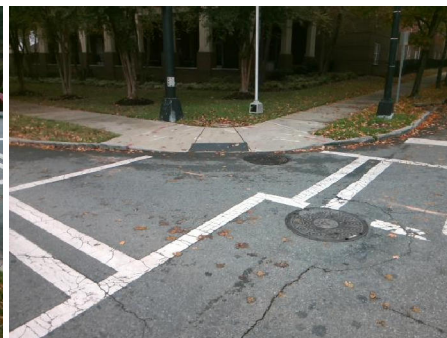
Not Found, R304.5.1

Compliance	Description	Data	Compliance	Description	Data
N/A	Ramp Length (in)	82.0	Yes	Ramp Slope (%)	7.9
No	Ramp Width (in)	30.0	Yes	Ramp XSlope (%)	0.3
N/A	Flare Type LT	N/A	N/A	Flare Type RT	N/A
N/A	Flare Slope LT (%)	N/A	N/A	Flare Slope RT (%)	N/A
N/A	Flare Traversable LT?	N/A	N/A	Flare Traversable RT?	N/A
N/A	Landing Length (in)	N/A	N/A	DWS Provided?	N/A
N/A	Landing Width (in)	N/A	N/A	DWS Contrast?	N/A
N/A	Landing Slope (%)	N/A	N/A	DWS Length (in)	N/A
N/A	Landing X Slope (%)	N/A	N/A	DWS Full Width?	N/A
N/A	Landing Curb? (Y/N)	N/A	N/A	DWS Offset (in)	N/A
N/A	Shared Landing?	N/A			
N/A	Gutter Ponding?	N/A	N/A	Gutter Slope (%)	N/A
N/A	Gutter Lip Ht (in)	N/A	N/A	Gutter X Slope (%)	N/A
N/A	Painted X Walk1?	Yes	N/A	Painted X Walk2?	Yes
	X Walk 1 Direction	To SE		X Walk 2 Direction	To NE
N/A	X Walk 1 Width (in)	111.0	N/A	X Walk 2 Width (in)	100.0
	X Walk 1 Slope (%)	0.5		X Walk 2 Slope (%)	3.9
	X Walk 1 X Slope (%)	2.1		X Walk 2 X Slope (%)	0.2

N/A	Ramp inside XWalk1?	Yes	N/A	Ramp inside XWalk2?	Yes
	Road Slope (%)	2.4	N/A	Clear Space?	N/A
	Road X Slope (%)	2.0	N/A	Clear Space to XWalk (in)	N/A
N/A	Any Obstructions?	N/A	N/A	Storm Grate/Utility Hazard?	N/A
	Obstruction Type			Storm Grate/Utility Type	
		N/A			N/A
		Yes		Surface Condition? (G/P)	Good

Remove & Replace Curb Ramp With Two New Directional Ramps or Equivalent.
