Access Compliance Report

Public Rights-of-Way

(Curb Ramps)

| Intersection ID: 3466 | Main Street: ENCHANTMENT_COVE_LN | Cross Street: WOODLAND_COVE_CT | Location: NW |

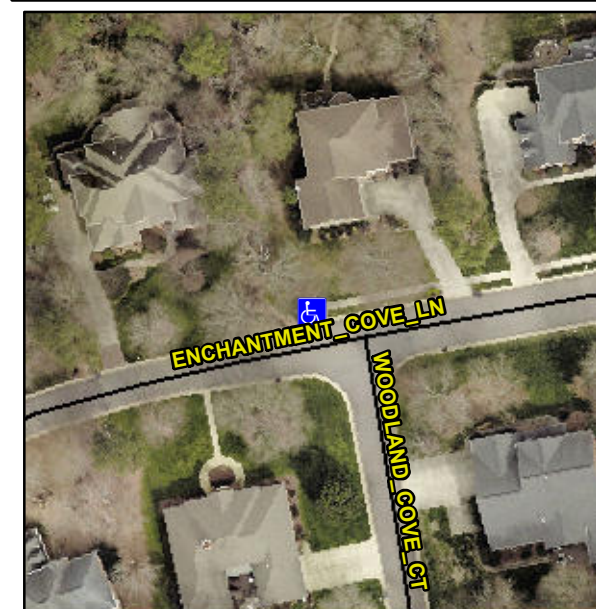
| ADA ID: 4C5B0DF605CE | Ramp Type: Perp | Initial Pass/Fail: Fail | Overall Compliance: No |
| Severity Score: 12.5 | | | |

Not Found, R304.2.2

| Compliance | Description | Data | Compliance | Description | Data |
|---|---|---|---|---|---|
| N/A | Ramp Length (in) | 96.0 | No | Ramp Slope (%) | 10.0 |

Possible Solutions:

Remove & Replace Entire Ramp.

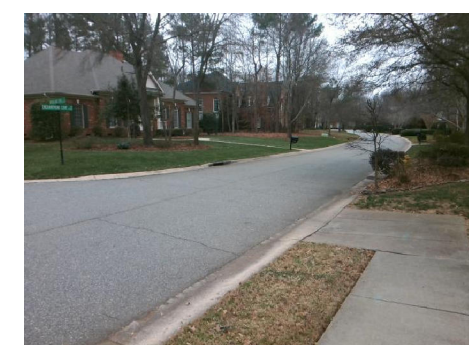
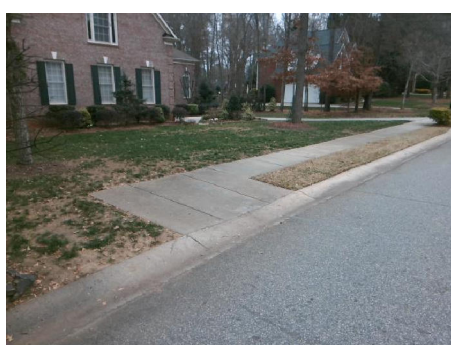
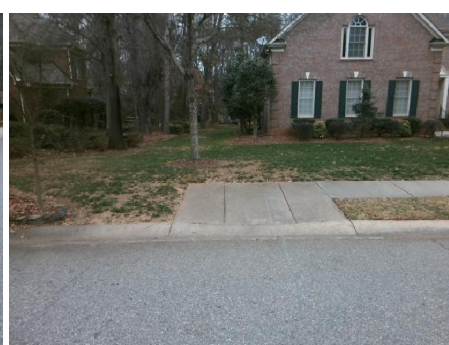
| Compliance | Description | Data | Compliance | Description | Data |
|---|---|---|---|---|---|
| Yes | Ramp Width (in) | 48.0 | Yes | Ramp XSlope (%) | 0.8 |
| | | | Yes | Surface Condition? (G/P) | Good |
