# Access Compliance Report

## Public Rights-of-Way

### (Curb Ramps)

Intersection ID: 44065	Main Street: WOODS_CORNER_CT	Cross Street: SEDGEMOOR_LN	Location: W
ADA ID: 4C69528B6E13	Ramp Type: PerpDiag	Initial Pass/Fail: Fail	Overall Compliance: No
Severity Score: 47.5			
Codes/Mitigation Info/Possible Solution		Field Measurements/Component Compliance

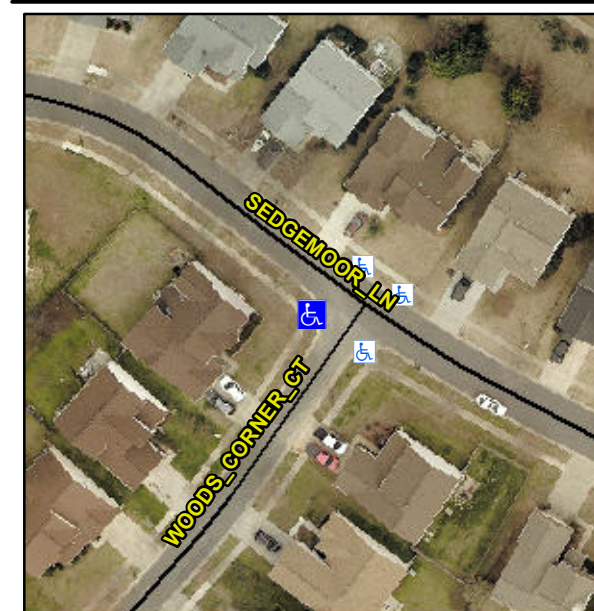
**R304.5.1, R304.2.2**

Compliance	Description	Data	Compliance	Description	Data
N/A	Ramp Length (in)	73.5	No	Ramp Slope (%)	8.8
No	Ramp Width (in)	25.0	Yes	Ramp XSlope (%)	1.2
N/A	Flare Type LT	N/A	N/A	Flare Type RT	N/A
N/A	Flare Slope LT (%)	N/A	N/A	Flare Slope RT (%)	N/A
N/A	Flare Traversable LT?	N/A	N/A	Flare Traversable RT?	N/A
N/A	Landing Length (in)	N/A	N/A	DWS Provided?	N/A
N/A	Landing Width (in)	N/A	N/A	DWS Contrast?	N/A
N/A	Landing Slope (%)	N/A	N/A	DWS Length (in)	N/A
N/A	Landing X Slope (%)	N/A	N/A	DWS Full Width?	N/A
N/A	Landing Curb? (Y/N)	N/A	N/A	DWS Offset (in)	N/A
N/A	Shared Landing?	N/A			
N/A	Gutter Ponding?	N/A	N/A	Gutter Slope (%)	N/A
N/A	Gutter Lip Ht (in)	N/A	N/A	Gutter X Slope (%)	N/A
N/A	Painted X Walk1?	No	N/A	Painted X Walk2?	No
	X Walk 1 Direction	To SE		X Walk 2 Direction	To NE
N/A	X Walk 1 Width (in)	N/A	N/A	X Walk 2 Width (in)	N/A
	X Walk 1 Slope (%)	0.3		X Walk 2 Slope (%)	3.9
	X Walk 1 X Slope (%)	0.2		X Walk 2 X Slope (%)	1.1

N/A	Ramp inside XWalk1?	N/A	N/A	Ramp inside XWalk2?	N/A
	Road Slope (%)	1.2	N/A	Clear Space?	N/A
	Road X Slope (%)	1.4	N/A	Clear Space to XWalk (in)	N/A
N/A	Any Obstructions?	N/A	N/A	Storm Grate/Utility Hazard?	N/A
	Obstruction Type			Storm Grate/Utility Type	
		N/A			N/A
			Yes	Surface Condition? (G/P)	Good

**Remove & Replace Curb Ramp With Two New Directional Ramps or Equivalent.**
