Access Compliance Report

Public Rights-of-Way

(Curb Ramps)

Intersection ID: 16757	Main Street: E_W_T_HARRIS_BV	Cross Street: MEADOWDALE_LN	Location: SE
ADA ID: 4C6AC47FAD29	Ramp Type: PerpDiag	Initial Pass/Fail: Fail	Overall Compliance: No
Severity Score: 13.75			
Codes/Mitigation Info/Possible Solution		Field Measurements/Component Compliance

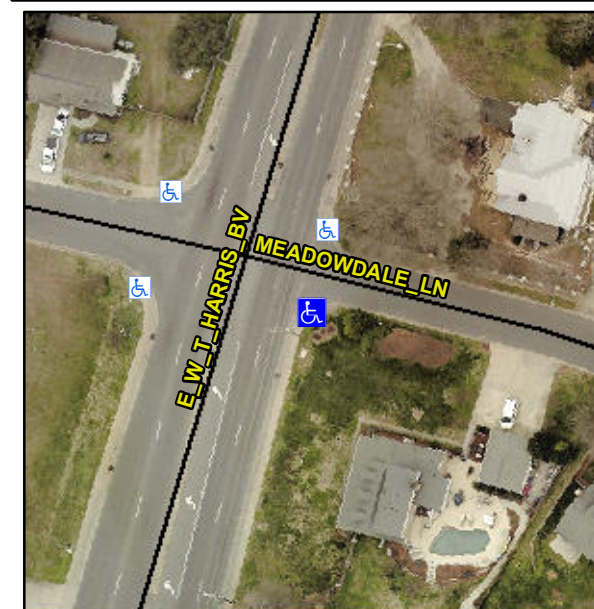
Not Found, R304.2.2, R304.5.3

Compliance	Description	Data	Compliance	Description	Data
N/A	Ramp Length (in)	70.0	No	Ramp Slope (%)	10.4
Yes	Ramp Width (in)	48.0	No	Ramp XSlope (%)	3.7
N/A	Flare Type LT	N/A	N/A	Flare Type RT	N/A
N/A	Flare Slope LT (%)	N/A	N/A	Flare Slope RT (%)	N/A
N/A	Flare Traversable LT?	N/A	N/A	Flare Traversable RT?	N/A
N/A	Landing Length (in)	N/A	N/A	DWS Provided?	N/A
N/A	Landing Width (in)	N/A	N/A	DWS Contrast?	N/A
N/A	Landing Slope (%)	N/A	N/A	DWS Length (in)	N/A
N/A	Landing X Slope (%)	N/A	N/A	DWS Full Width?	N/A
N/A	Landing Curb? (Y/N)	N/A	N/A	DWS Offset (in)	N/A
N/A	Shared Landing?	N/A			
N/A	Gutter Ponding?	N/A	N/A	Gutter Slope (%)	N/A
N/A	Gutter Lip Ht (in)	N/A	N/A	Gutter X Slope (%)	N/A
N/A	Painted X Walk1?	No	N/A	Painted X Walk2?	No
	X Walk 1 Direction	To NE		X Walk 2 Direction	To NW
N/A	X Walk 1 Width (in)	N/A	N/A	X Walk 2 Width (in)	N/A
	X Walk 1 Slope (%)	2.8		X Walk 2 Slope (%)	5.6
	X Walk 1 X Slope (%)	4.4		X Walk 2 X Slope (%)	1.3

N/A	Ramp inside XWalk1?	N/A	N/A	Ramp inside XWalk2?	N/A
	Road Slope (%)	2.6	N/A	Clear Space?	N/A
	Road X Slope (%)	5.5	N/A	Clear Space to XWalk (in)	N/A
N/A	Any Obstructions?	N/A	N/A	Storm Grate/Utility Hazard?	N/A
	Obstruction Type			Storm Grate/Utility Type	
		N/A			N/A
		Yes		Surface Condition? (G/P)	Good

Remove & Replace Curb Ramp With Two New Directional Ramps or Equivalent.
