Access Compliance Report

Public Rights-of-Way

(Curb Ramps)

Intersection ID: 50544	Main Street: ALCEA_ST	Cross Street: CAYENNE_DR	Location: S
ADA ID: 4C6C1FA16FD6	Ramp Type: PerpDiag	Initial Pass/Fail: Fail	Overall Compliance: No
			Severity Score: 13.75

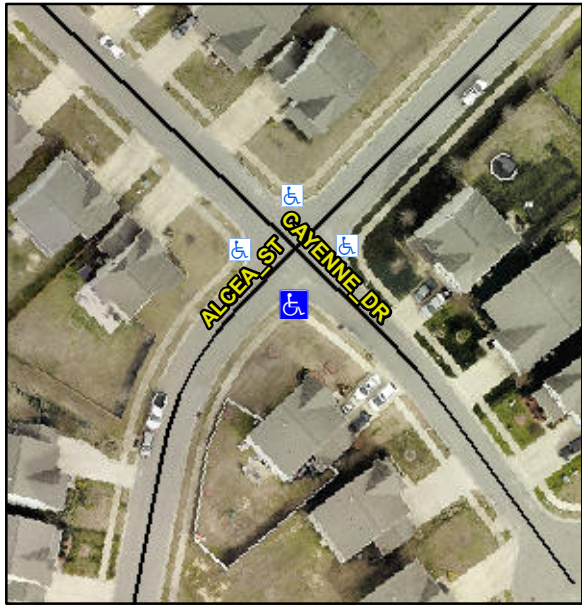
Possible Solutions:		Compliance	Description	Data	Compliance	Description	Data
	Remove & Replace Curb Ramp With Two New Directional Ramps or Equivalent.		N/A	Ramp Length (in)	49.0	No	Ramp Slope (%)	11.8
			Yes	Ramp Width (in)	48.0	No	Ramp XSlope (%)	3.9
			N/A	Flare Type LT	N/A	N/A	Flare Type RT	N/A
			N/A	Flare Slope LT (%)	N/A	N/A	Flare Slope RT (%)	N/A
			N/A	Flare Traversable LT?	N/A	N/A	Flare Traversable RT?	N/A
			N/A	Landing Length (in)	N/A	N/A	DWS Provided?	N/A
			N/A	Landing Width (in)	N/A	N/A	DWS Contrast?	N/A
			N/A	Landing Slope (%)	N/A	N/A	DWS Length (in)	N/A
			N/A	Landing X Slope (%)	N/A	N/A	DWS Full Width?	N/A
Surveyor Notes:		N/A	N/A	Landing Curb? (Y/N)	N/A	N/A	DWS Offset (in)	N/A
		N/A	N/A	Shared Landing?	N/A			
PROW/ADA:		N/A	N/A	Gutter Ponding?	N/A	N/A	Gutter Slope (%)	N/A
		N/A	N/A	Gutter Lip Ht (in)	N/A	N/A	Gutter X Slope (%)	N/A
