# Access Compliance Report

## Public Rights-of-Way

### (Curb Ramps)

Intersection ID: 25759	Main Street: PLANTERS RIDGE RD	Cross Street: PROVIDENCE VIEW LN	Location: NE
ADA ID: 4C750E72144D	Ramp Type: Perp	Initial Pass/Fail: Fail	Overall Compliance: No
Severity Score: 72.5			
Codes/Mitigation Info/Possible Solution		Field Measurements/Component Compliance

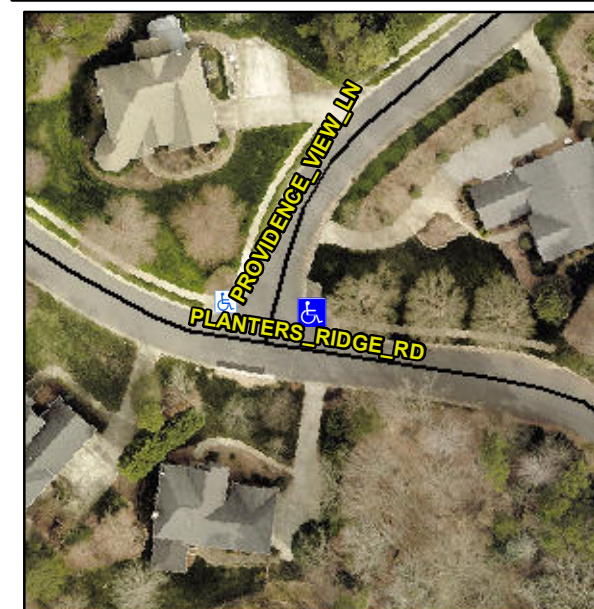
**Not Found, R304.5.1, R304.2.2, R304.5.3**

Compliance	Description	Data	Compliance	Description	Data
N/A	Ramp Length (in)	96.0	No	Ramp Slope (%)	8.4
No	Ramp Width (in)	25.0	No	Ramp XSlope (%)	11.5
N/A	Flare Type LT	N/A	N/A	Flare Type RT	N/A
N/A	Flare Slope LT (%)	N/A	N/A	Flare Slope RT (%)	N/A
N/A	Flare Traversable LT?	N/A	N/A	Flare Traversable RT?	N/A
N/A	Landing Length (in)	N/A	N/A	DWS Provided?	N/A
N/A	Landing Width (in)	N/A	N/A	DWS Contrast?	N/A
N/A	Landing Slope (%)	N/A	N/A	DWS Length (in)	N/A
N/A	Landing X Slope (%)	N/A	N/A	DWS Full Width?	N/A
N/A	Landing Curb? (Y/N)	N/A	N/A	DWS Offset (in)	N/A
N/A	Shared Landing?	N/A			
N/A	Gutter Ponding?	N/A	N/A	Gutter Slope (%)	N/A
N/A	Gutter Lip Ht (in)	N/A	N/A	Gutter X Slope (%)	N/A
N/A	Painted X Walk1?	No	N/A	Painted X Walk2?	N/A
	X Walk 1 Direction	To W		X Walk 2 Direction	N/A
N/A	X Walk 1 Width (in)	N/A	N/A	X Walk 2 Width (in)	N/A
	X Walk 1 Slope (%)	2.6		X Walk 2 Slope (%)	N/A
	X Walk 1 X Slope (%)	6.9		X Walk 2 X Slope (%)	N/A

**Remove & Replace Entire Ramp.**
