# Access Compliance Report

## Public Rights-of-Way

### (Curb Ramps)

Intersection ID: 17676	Main Street: N_SHARON_AMITY_RD	Cross Street: WINDEMERE_LN	Location: NE
ADA ID: 4C79EB1FF089	Ramp Type: PerpDiag	Initial Pass/Fail: Fail	Overall Compliance: No
		Severity Score: 47.5	
Codes/Mitigation Info/Possible Solution		Field Measurements/Component Compliance

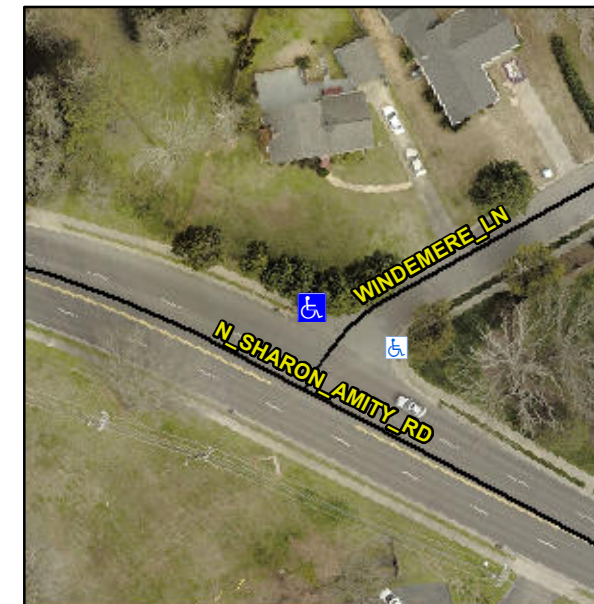
**Not Found, R304.5.1, R304.5.3**

Compliance	Description	Data	Compliance	Description	Data
N/A	Ramp Length (in)	60.0	Yes	Ramp Slope (%)	5.5
No	Ramp Width (in)	30.0	No	Ramp XSlope (%)	6.8
N/A	Flare Type LT	N/A	N/A	Flare Type RT	N/A
N/A	Flare Slope LT (%)	N/A	N/A	Flare Slope RT (%)	N/A
N/A	Flare Traversable LT?	N/A	N/A	Flare Traversable RT?	N/A
N/A	Landing Length (in)	N/A	N/A	DWS Provided?	N/A
N/A	Landing Width (in)	N/A	N/A	DWS Contrast?	N/A
N/A	Landing Slope (%)	N/A	N/A	DWS Length (in)	N/A
N/A	Landing X Slope (%)	N/A	N/A	DWS Full Width?	N/A
N/A	Landing Curb? (Y/N)	N/A	N/A	DWS Offset (in)	N/A
N/A	Shared Landing?	N/A			
N/A	Gutter Ponding?	N/A	N/A	Gutter Slope (%)	N/A
N/A	Gutter Lip Ht (in)	N/A	N/A	Gutter X Slope (%)	N/A
N/A	Painted X Walk1?	No	N/A	Painted X Walk2?	No
	X Walk 1 Direction	To SW		X Walk 2 Direction	To SE
N/A	X Walk 1 Width (in)	N/A	N/A	X Walk 2 Width (in)	N/A
	X Walk 1 Slope (%)	7.9		X Walk 2 Slope (%)	1.2
	X Walk 1 X Slope (%)	3.6		X Walk 2 X Slope (%)	7.5

N/A	Ramp inside XWalk1?	N/A	N/A	Ramp inside XWalk2?	N/A
	Road Slope (%)	9.0	N/A	Clear Space?	N/A
	Road X Slope (%)	1.3	N/A	Clear Space to XWalk (in)	N/A
N/A	Any Obstructions?	N/A	N/A	Storm Grate/Utility Hazard?	N/A
	Obstruction Type			Storm Grate/Utility Type	
		N/A			N/A
			Yes	Surface Condition? (G/P)	Good

**Remove & Replace Curb Ramp With Two New Directional Ramps or Equivalent.**

Total Cost: \$ 3200.00
