Access Compliance Report

Public Rights-of-Way

(Curb Ramps)

Intersection ID: 3937	Main Street: CULLINGFORD_LN	Cross Street: ROYCE_HALL_LN	Location: SE
ADA ID: 4C7A12ABECC0	Ramp Type: BlendTrans2	Initial Pass/Fail: Fail	Overall Compliance: No
Severity Score: 33.75			
Codes/Mitigation Info/Possible Solution		Field Measurements/Component Compliance

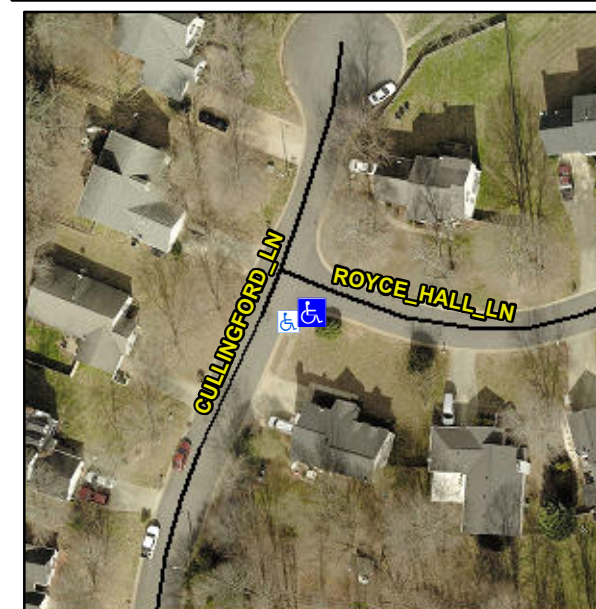
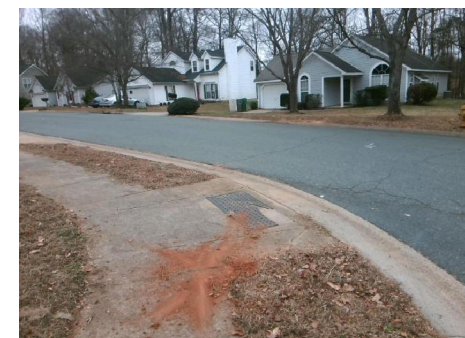
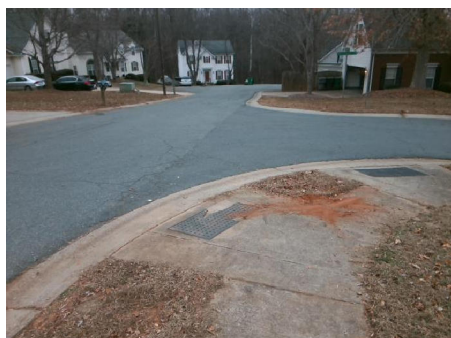
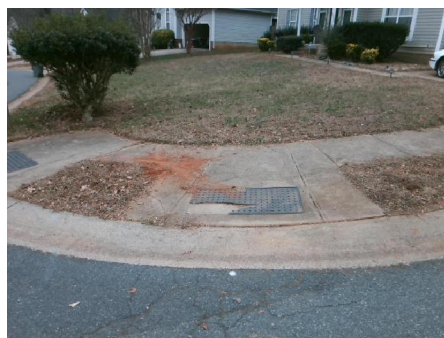
Not Found, R304.5.1, R304.5.3

Compliance	Description	Data	Compliance	Description	Data
N/A	Ramp Length (in)	96.0	Yes	BlendTrans Slope (%)	4.8
No	Ramp Width (in)	39.0	No	BlendTrans XSlope (%)	8.5
N/A	Flare Type LT	N/A	N/A	Flare Type RT	N/A
N/A	Flare Slope LT (%)	N/A	N/A	Flare Slope RT (%)	N/A
N/A	Flare Traversable LT?	N/A	N/A	Flare Traversable RT?	N/A
N/A	Landing Length (in)	N/A	N/A	DWS Provided?	N/A
N/A	Landing Width (in)	N/A	N/A	DWS Contrast?	N/A
N/A	Landing Slope (%)	N/A	N/A	DWS Length (in)	N/A
N/A	Landing X Slope (%)	N/A	N/A	DWS Full Width?	N/A
N/A	Landing Curb? (Y/N)	N/A	N/A	DWS Offset (in)	N/A
N/A	Shared Landing?	N/A			
N/A	Gutter Ponding?	N/A	N/A	Gutter Slope (%)	N/A
N/A	Gutter Lip Ht (in)	N/A	N/A	Gutter X Slope (%)	N/A
N/A	Painted X Walk1?	No	N/A	Painted X Walk2?	N/A
	X Walk 1 Direction	To N		X Walk 2 Direction	N/A
	X Walk 1 Width (in)	N/A		X Walk 2 Width (in)	N/A
	X Walk 1 Slope (%)	0.7		X Walk 2 Slope (%)	N/A
	X Walk 1 X Slope (%)	5.1		X Walk 2 X Slope (%)	N/A

N/A	Ramp inside XWalk1?	N/A	N/A	Ramp inside XWalk2?	N/A
	Road Slope (%)	5.1		Clear Space?	N/A
	Road X Slope (%)	0.7	N/A	Clear Space to XWalk (in)	N/A
N/A	Any Obstructions?	N/A	N/A	Storm Grate/Utility Hazard?	N/A
	Obstruction Type			Storm Grate/Utility Type	
		N/A			N/A
			Yes	Surface Condition? (G/P)	Good
			No	Curb Slope (%)	13.3

Remove & Replace Curb Ramp With Two New Directional Ramps or Equivalent.
