Access Compliance Report

Public Rights-of-Way

(Curb Ramps)

Intersection ID: 15011	Main Street: ALBEMARLE_RD	Cross Street: COPPER_CREEK_CT	Location: NE
ADA ID: 4C826754A8BE	Ramp Type: PerpDiag	Initial Pass/Fail: Fail	Overall Compliance: No
		Severity Score: 12.5

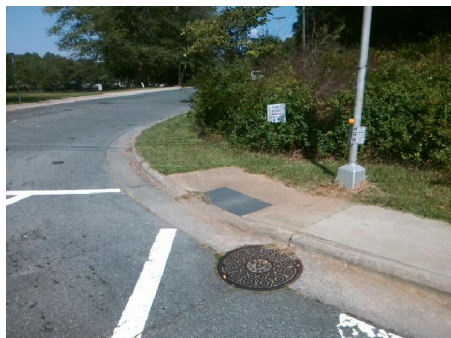
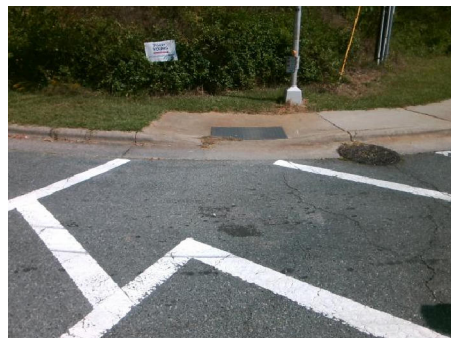
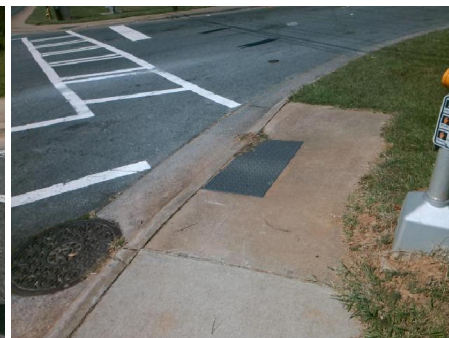
Not Found, R304.2.2

Compliance	Description	Data	Compliance	Description	Data
N/A	Ramp Length (in)	62.0	No	Ramp Slope (%)	9.5
Yes	Ramp Width (in)	48.0	Yes	Ramp XSlope (%)	0.0
N/A	Flare Type LT	N/A	N/A	Flare Type RT	N/A
N/A	Flare Slope LT (%)	N/A	N/A	Flare Slope RT (%)	N/A
N/A	Flare Traversable LT?	N/A	N/A	Flare Traversable RT?	N/A
N/A	Landing Length (in)	N/A	N/A	DWS Provided?	N/A
N/A	Landing Width (in)	N/A	N/A	DWS Contrast?	N/A
N/A	Landing Slope (%)	N/A	N/A	DWS Length (in)	N/A
N/A	Landing X Slope (%)	N/A	N/A	DWS Full Width?	N/A
N/A	Landing Curb? (Y/N)	N/A	N/A	DWS Offset (in)	N/A
N/A	Shared Landing?	N/A			
N/A	Gutter Ponding?	N/A	N/A	Gutter Slope (%)	N/A
N/A	Gutter Lip Ht (in)	N/A	N/A	Gutter X Slope (%)	N/A
N/A	Painted X Walk1?	Yes	N/A	Painted X Walk2?	Yes
	X Walk 1 Direction	To SW		X Walk 2 Direction	To SE
N/A	X Walk 1 Width (in)	80.0	N/A	X Walk 2 Width (in)	67.0
	X Walk 1 Slope (%)	0.5		X Walk 2 Slope (%)	0.3
	X Walk 1 X Slope (%)	1.2		X Walk 2 X Slope (%)	0.1

N/A	Ramp inside XWalk1?	Yes	N/A	Ramp inside XWalk2?	No
	Road Slope (%)	0.1	N/A	Clear Space?	N/A
	Road X Slope (%)	1.5	N/A	Clear Space to XWalk (in)	N/A
N/A	Any Obstructions?	N/A	N/A	Storm Grate/Utility Hazard?	N/A
	Obstruction Type			Storm Grate/Utility Type	
		N/A			N/A
			Yes	Surface Condition? (G/P)	Good

Remove & Replace Curb Ramp With Two New Directional Ramps or Equivalent. Restripe Crosswalk.
